# U. S. S. HORNET (CV8)

## LOSS IN ACTION

26 OCTOBER, 1942

WAR DAMAGE REPORT No. 30

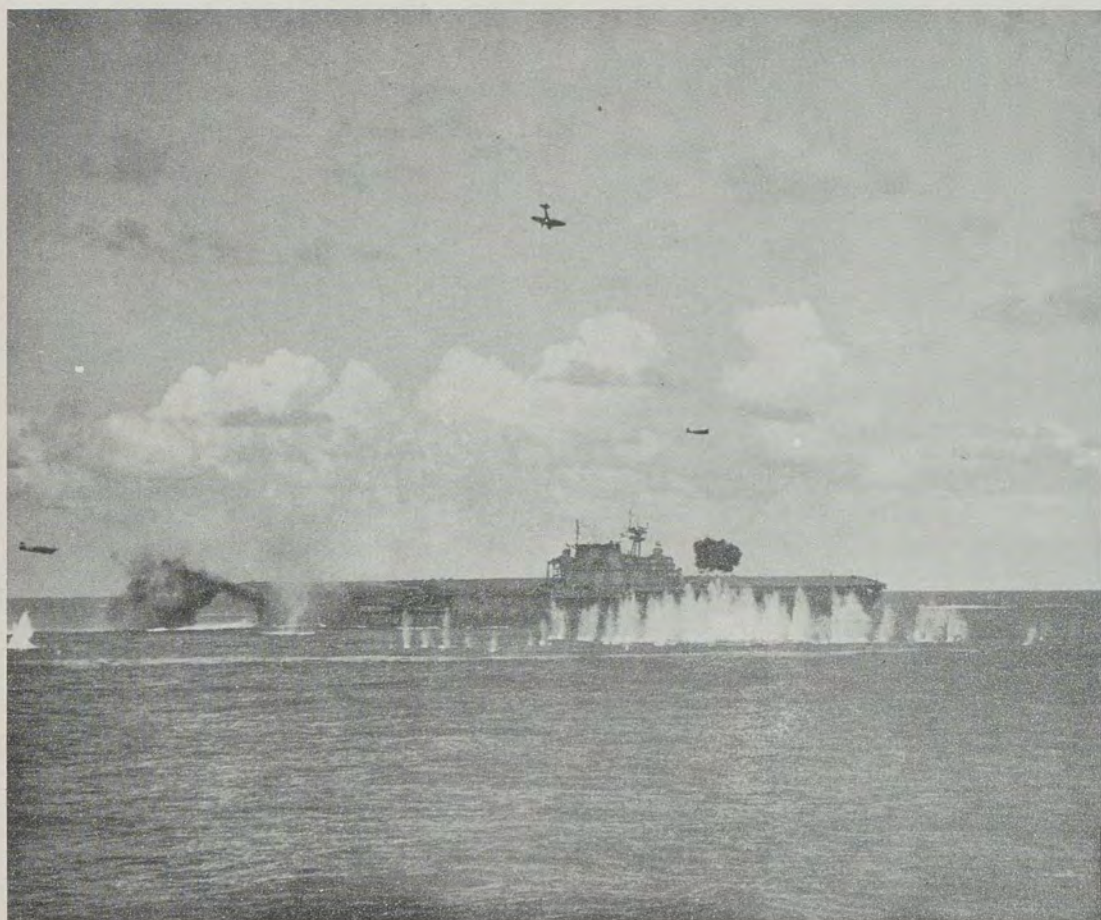
Photo 1: U.S.S. HORNET during morning attack. Note smoke on flight deck from the two bomb hits aft. Note "suicide" dive bomber about to crash into leading edge of stack.

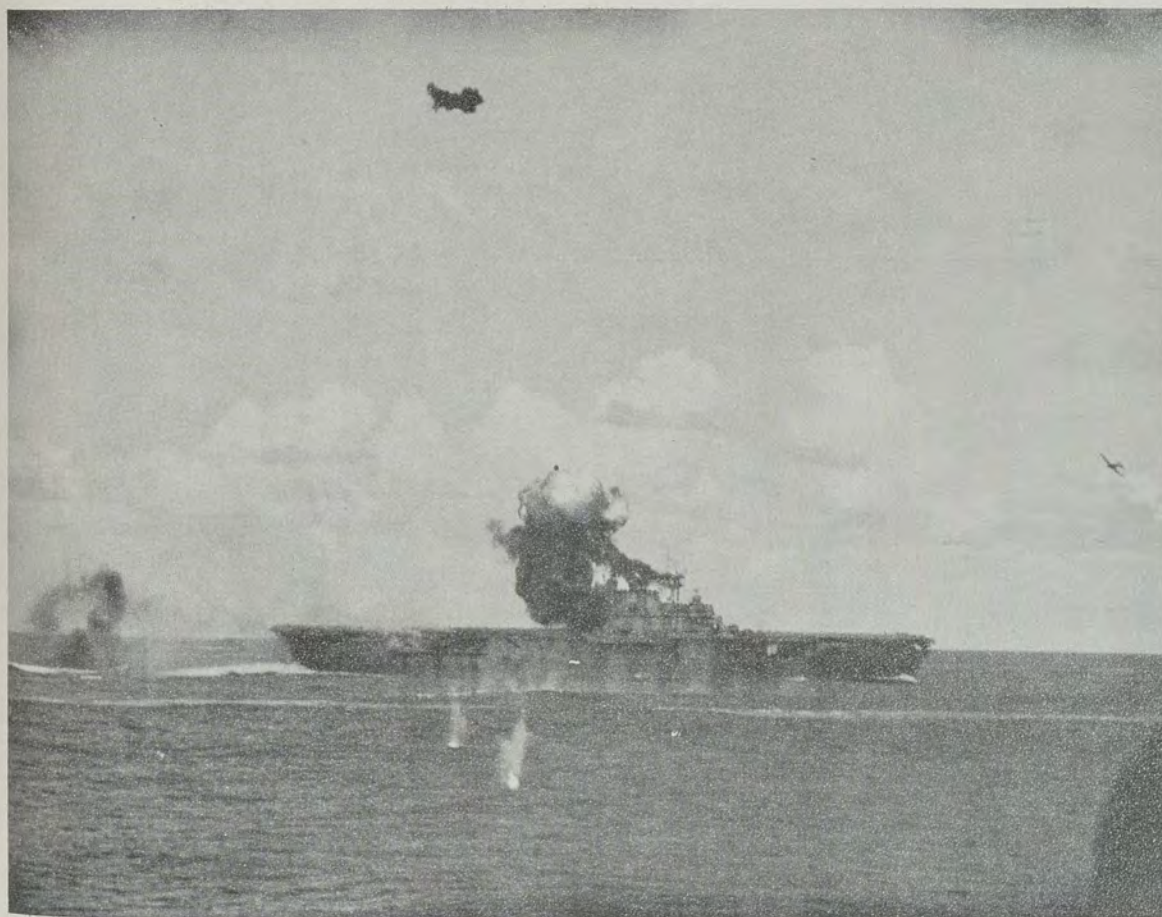
Photo 2: U.S.S. HORNET during morning attack. "Suicide" dive bomber, in photo No. 1, has just crashed into the leading edge of the stack. Note smoke coming from hanger deck due to bomb hits aft.

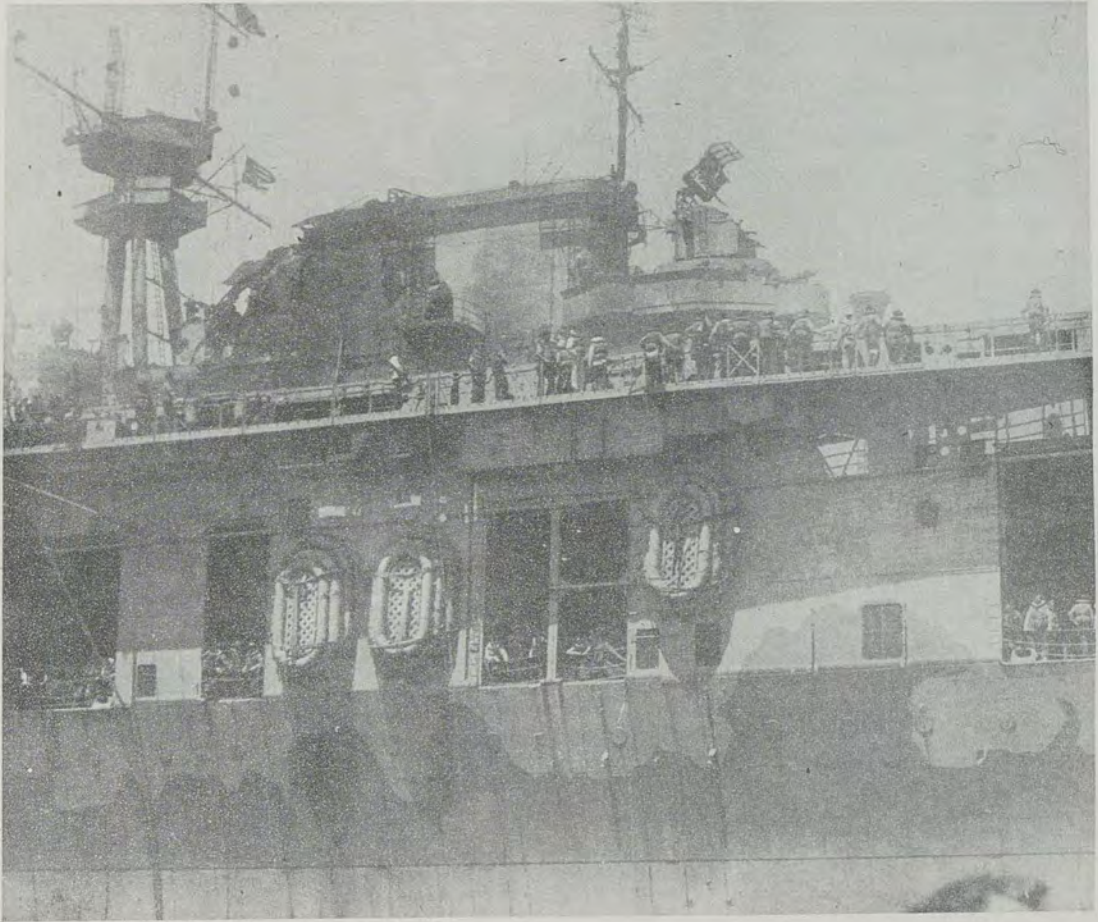
Photo 3: Port side view of damage to the stack as a result of enemy dive bomber crash.

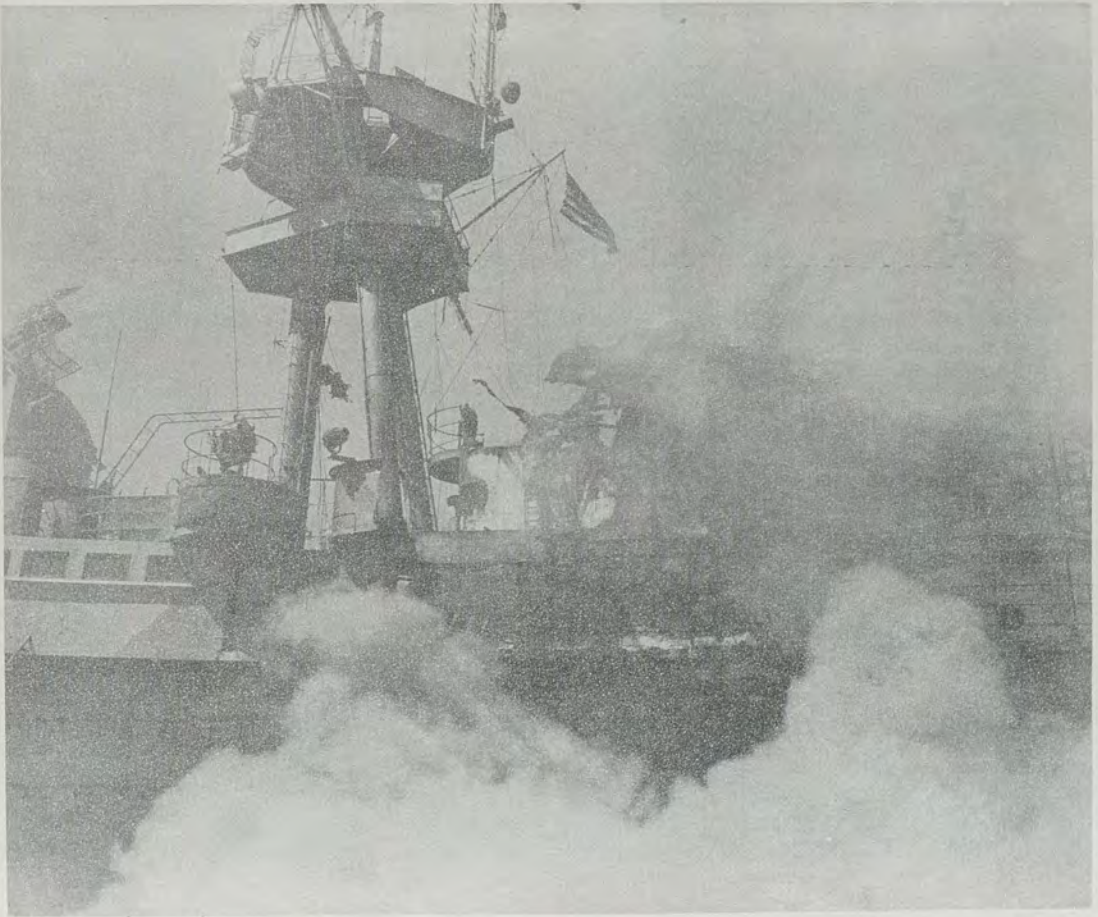
Photo 4: Close-up view, port side, of damage to stack immediately after crash of enemy dive bomber. Note damage to stack walkway. Note destruction of signal forward of stack.

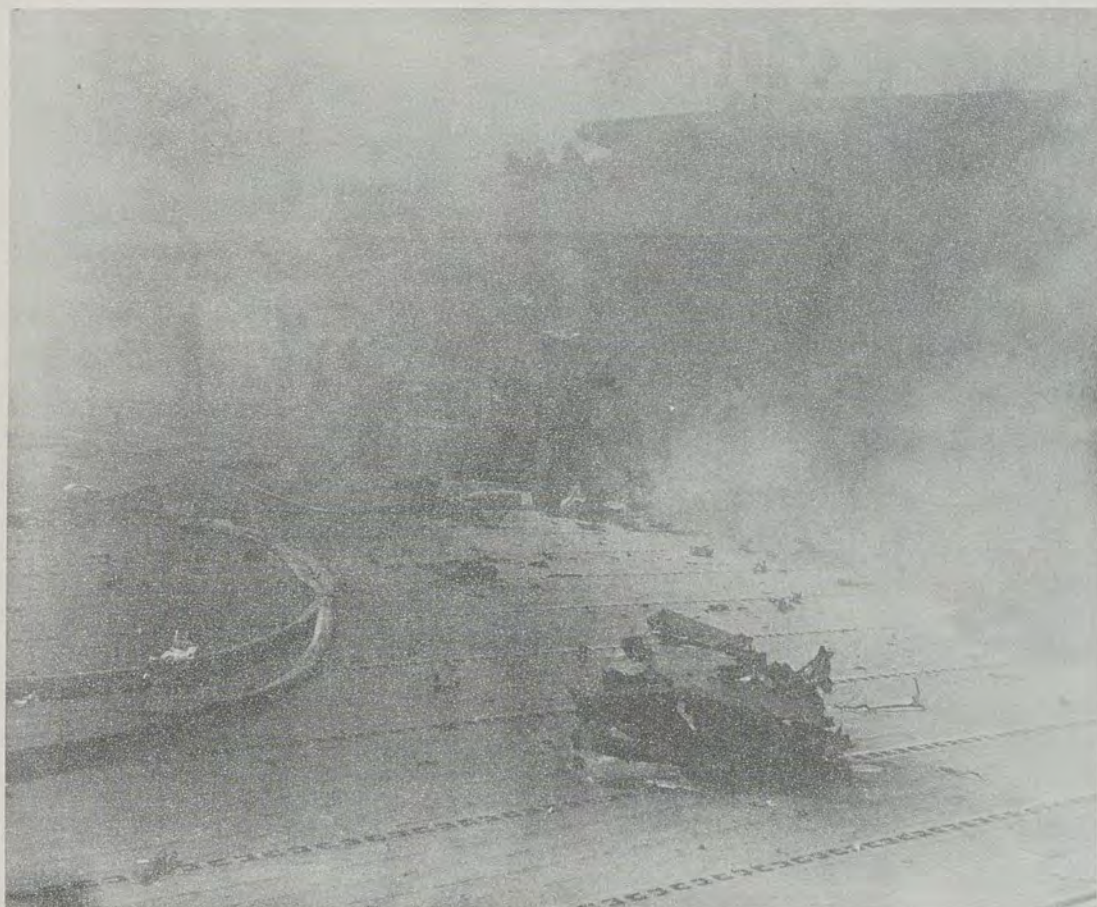
Photo 5: Close-up view of flight deck in way of stack showing wreckage of enemy dive bomber.

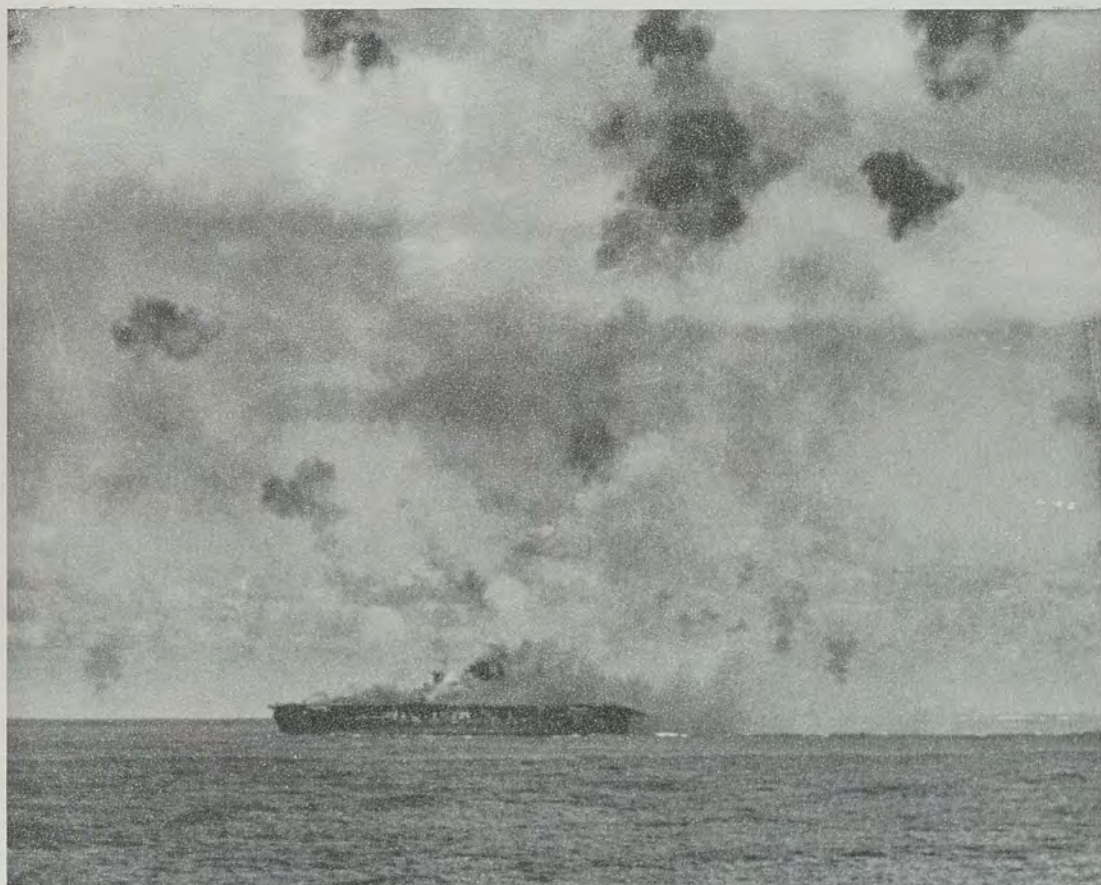
Photo 6: U.S.S. HORNET during latter part of morning attack just after an enemy dive bomber has rounded bow and crashed into port side gallery deck just forward of No.1 elevator. Note heavy smoke amidships from crash of first enemy dive bomber. Note starboard list as a result of the two torpedo hits.

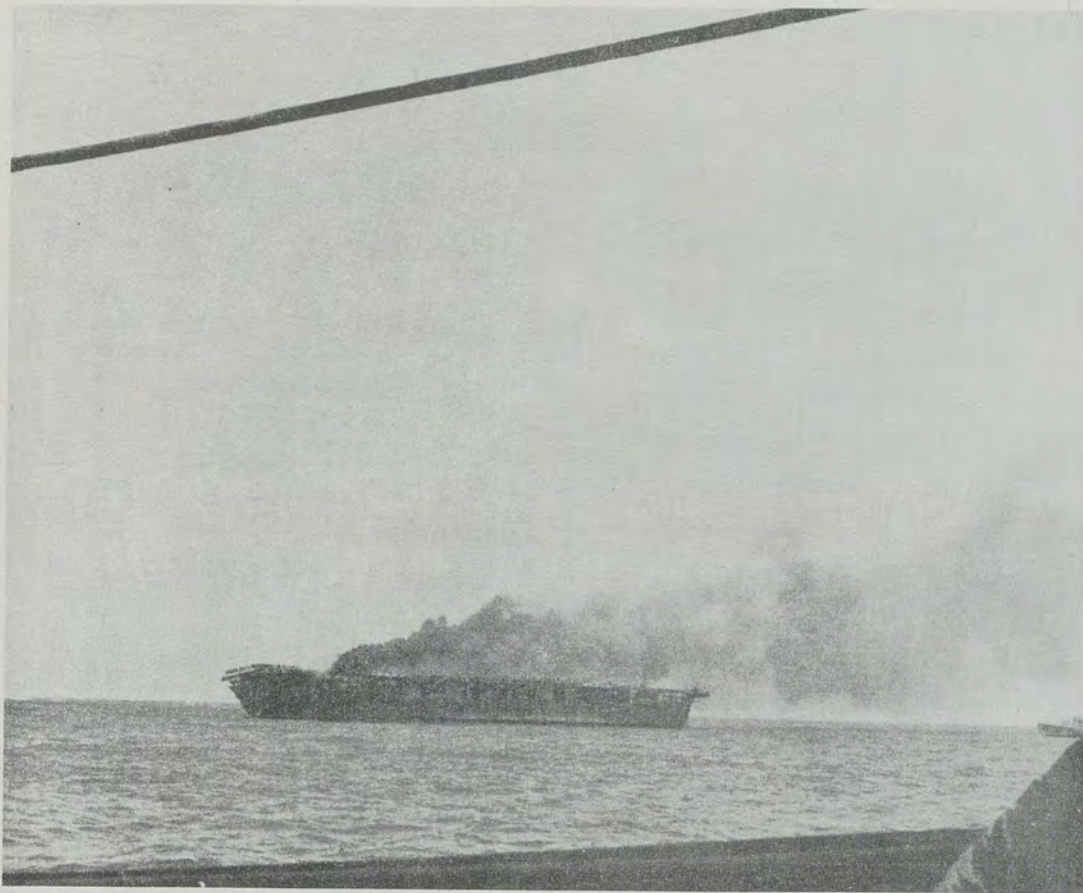
Photo 7: U.S.S. HORNET dead in the water after morning attack. Note smoke forward from crash of second enemy dive bomber. List is about  $7^{\circ}$  to starboard.

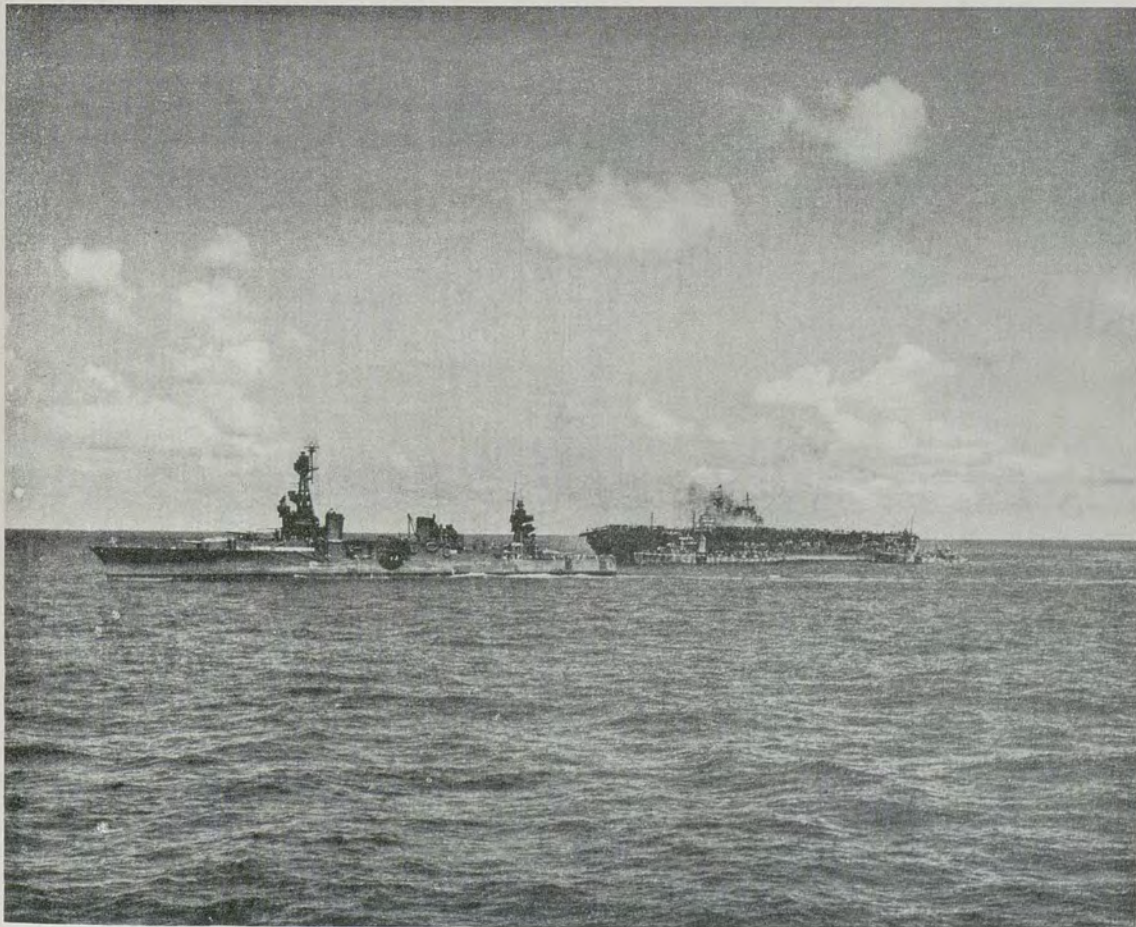
Photo 8: U.S.S. RUSSELL, U.S.S. MUSTIN along port side and U.S.S. MORRIS along starboard side (only top of mast visible) assisting U.S.S. HORNET in fighting fires after the morning attack. U.S.S. NORTHAMPTON standing by to commence towing operations.

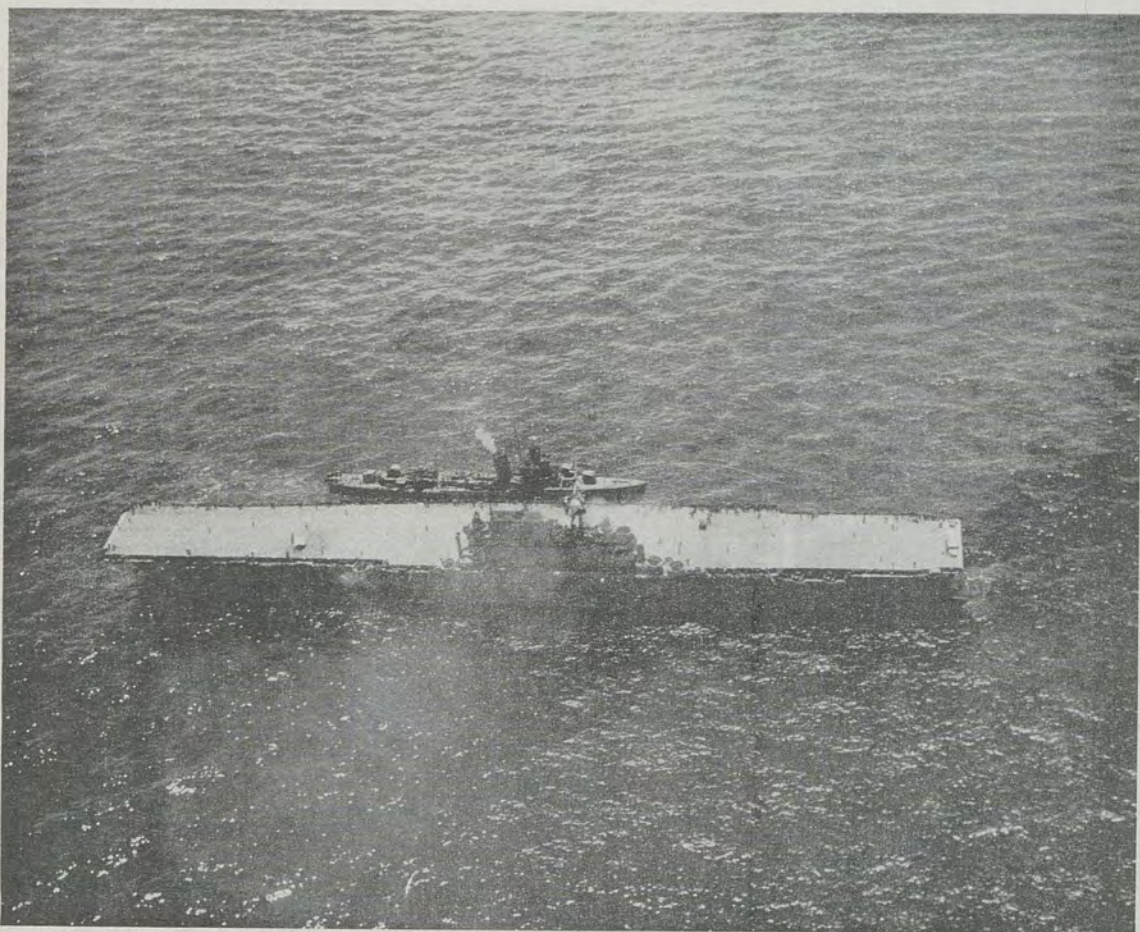
Photo 9: Aerial view of U.S.S. HORNET during lull between morning and afternoon attacks. Note hole in flight deck aft and damage to leading edge of stack. Note bucket brigades still fighting fires on flight deck near the stack.

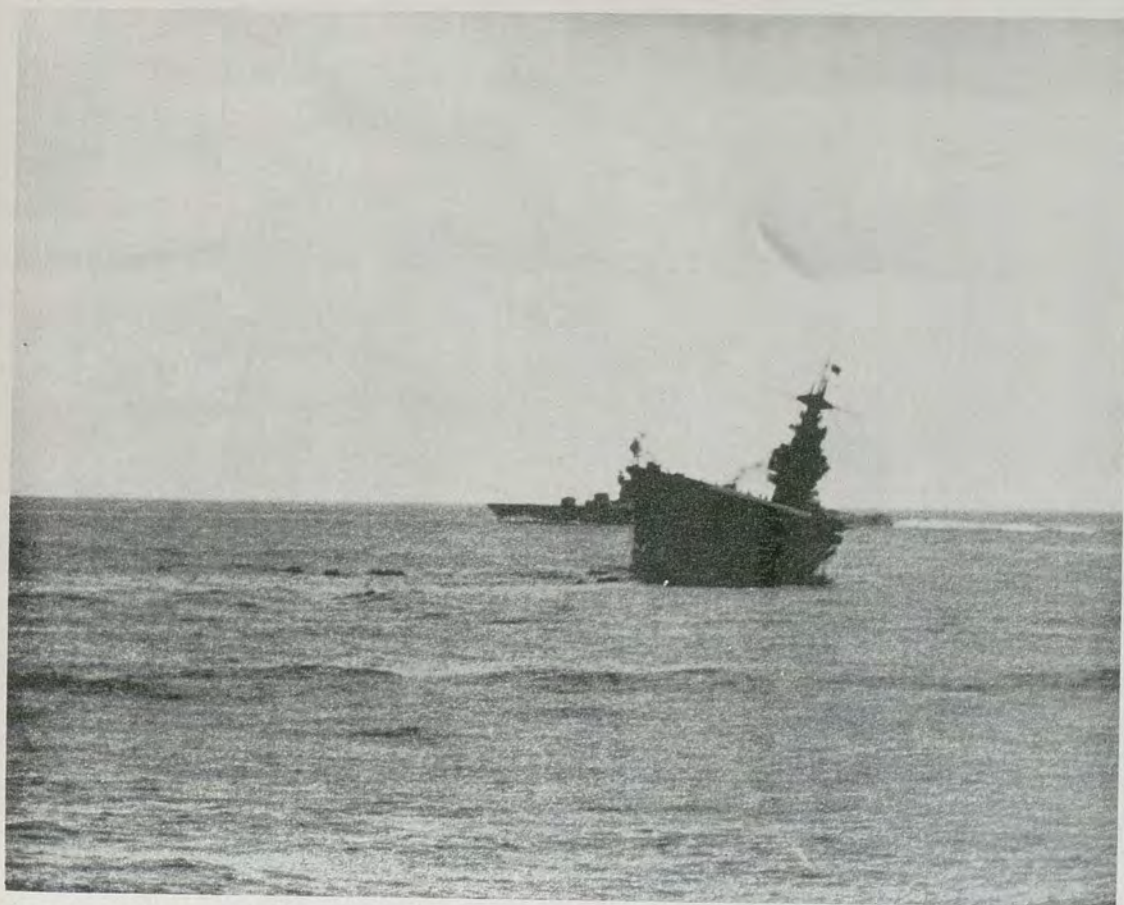
Photo 10: Stern view of U.S.S. HORNET during abandoning some time before last attack.

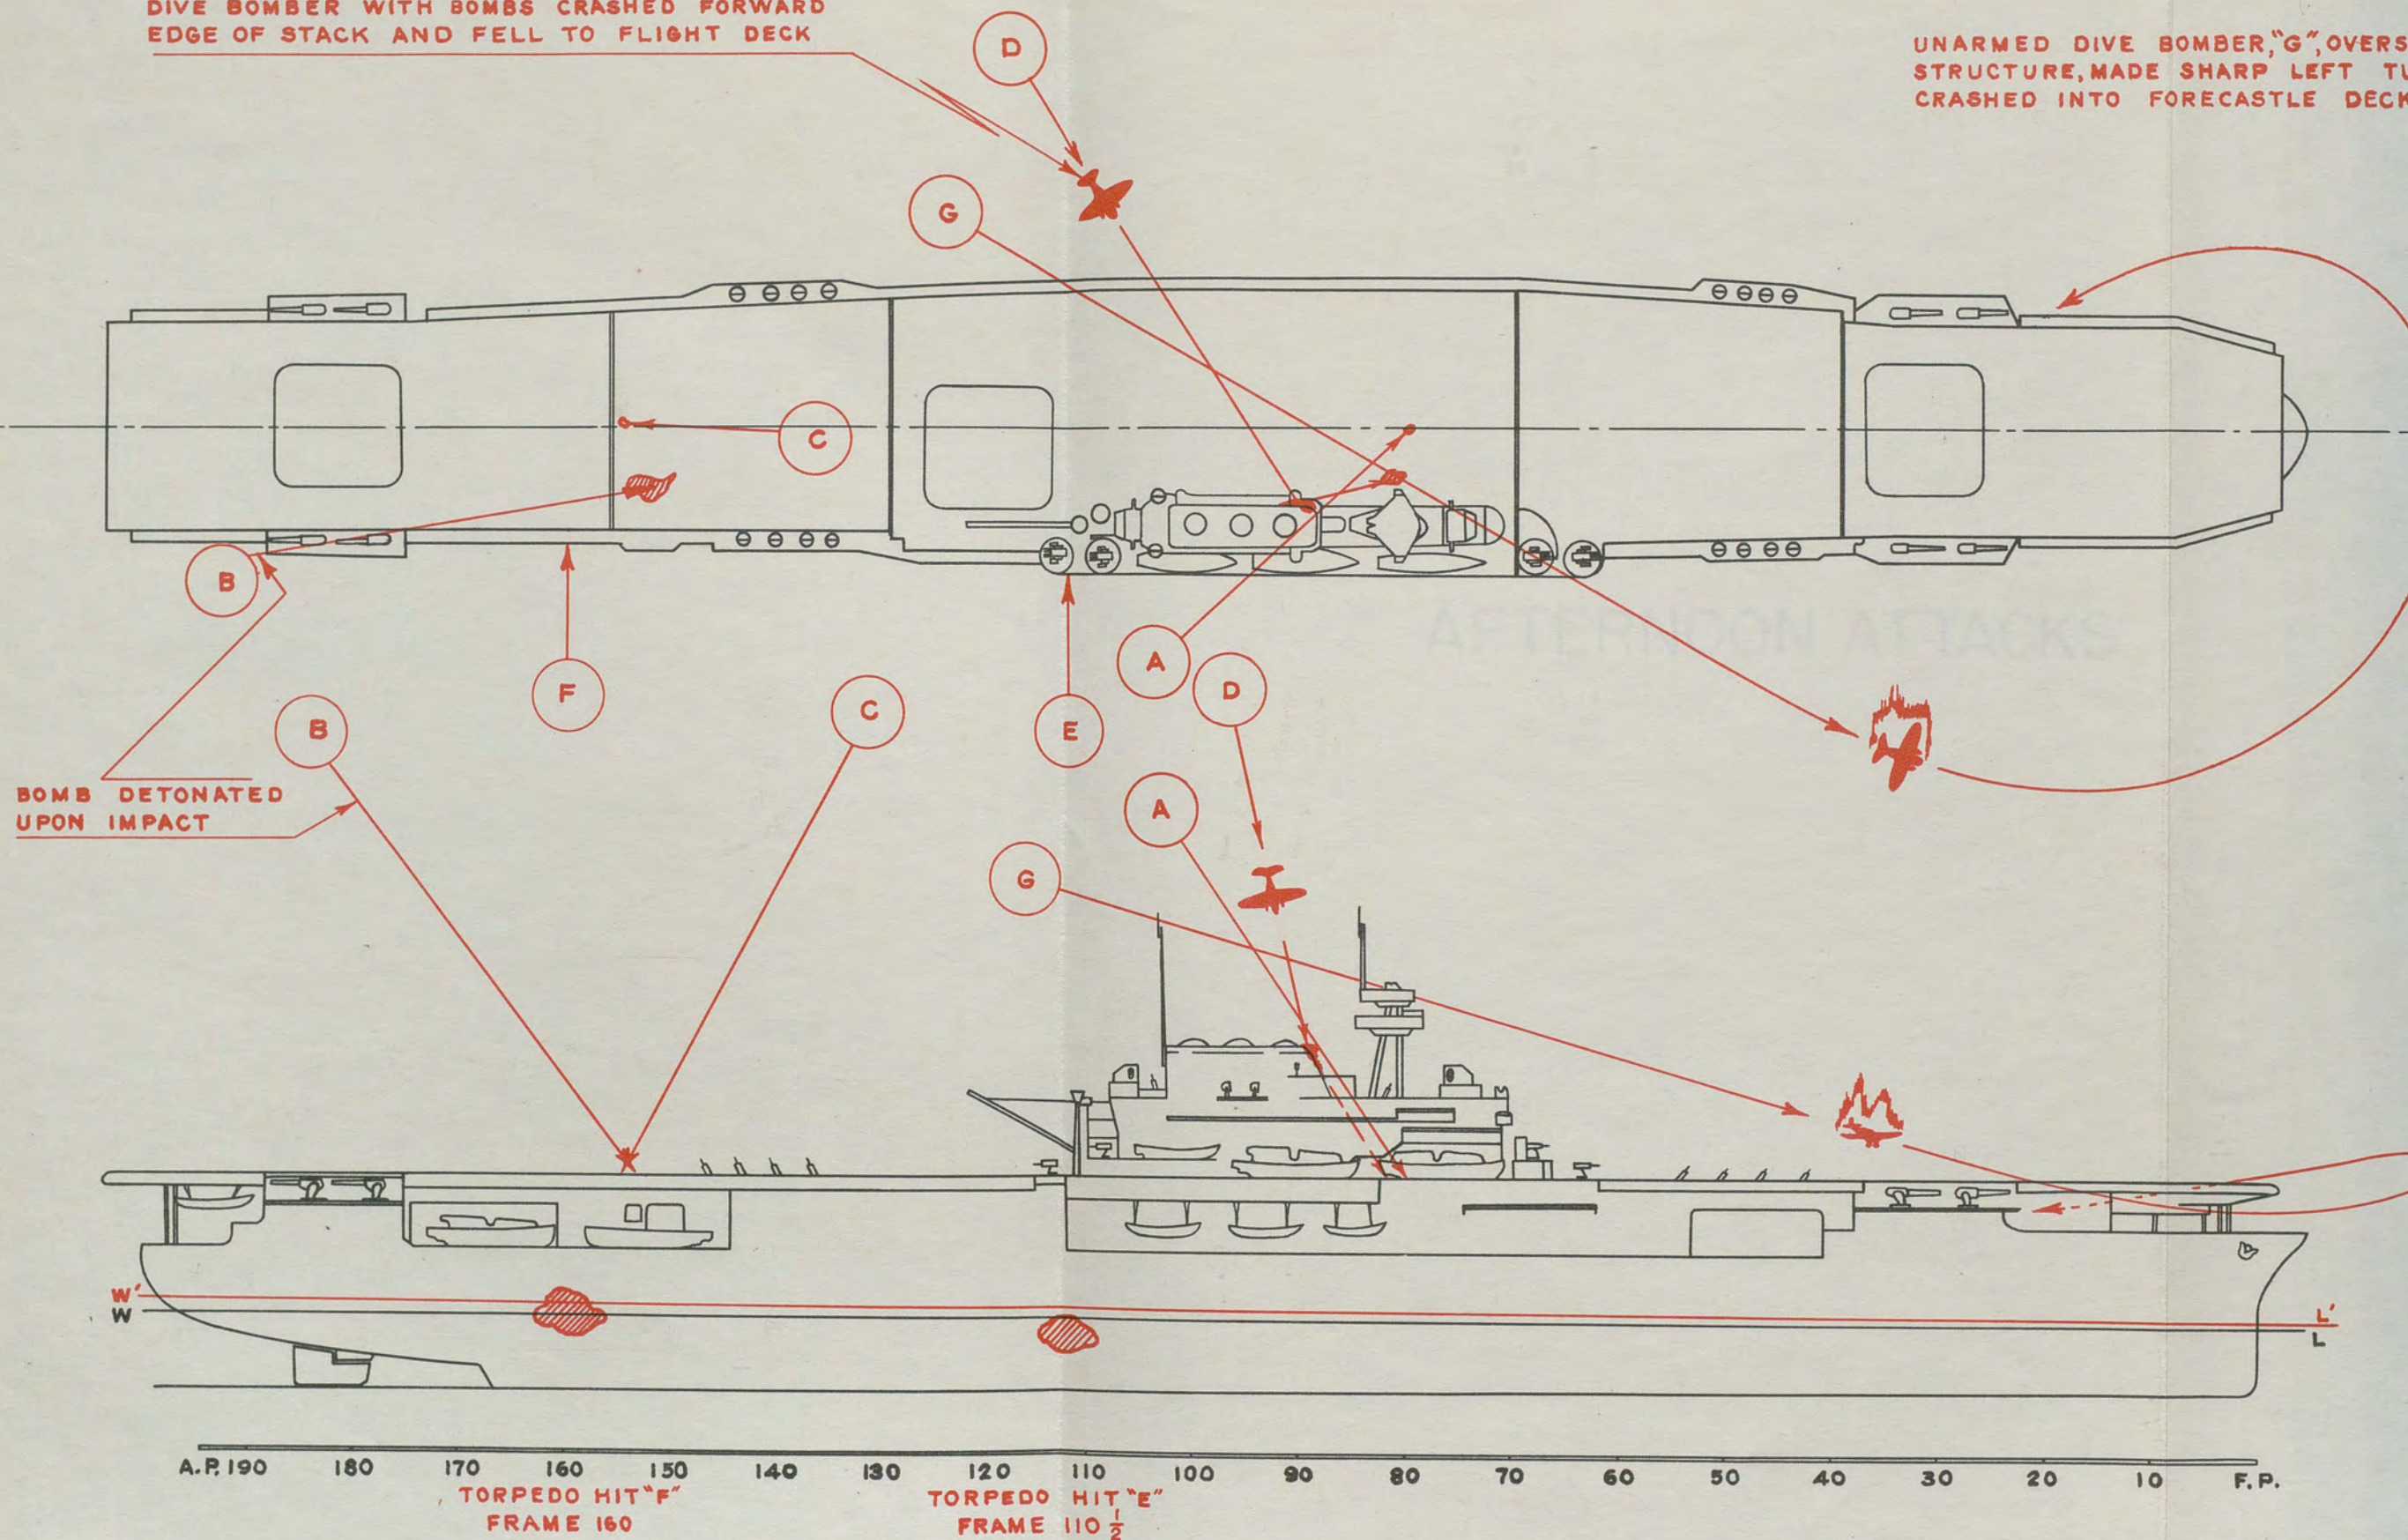
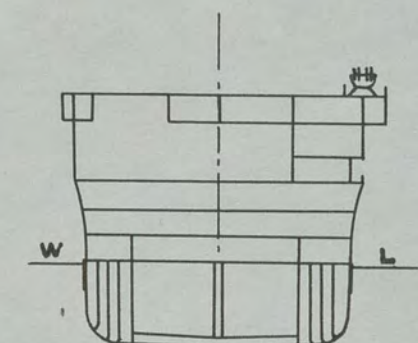
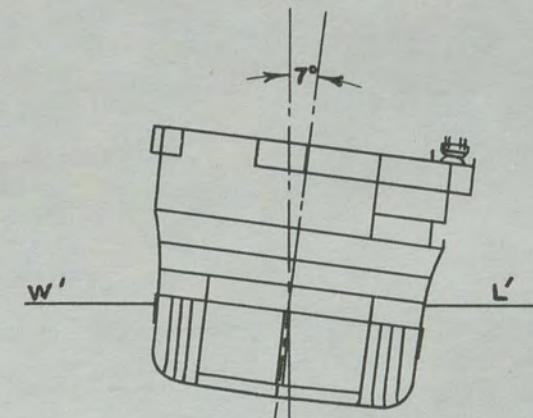
PLATE I

DIVE BOMBER WITH BOMBS CRASHED FORWARD  
EDGE OF STACK AND FELL TO FLIGHT DECK

UNARMED DIVE BOMBER, "G", OVERSHOT SUPER-  
STRUCTURE, MADE SHARP LEFT TURN AND  
CRASHED INTO FORECASTLE DECK, PORT SIDE

CONDITION BEFORE ATTACK  
FR. 112 - LOOKING FOR'D  
MEAN DRAFT ~ 27 FT.

CONDITION AFTER ATTACK  
FR. 112 - LOOKING FOR'D  
MEAN DRAFT ~ 30.5 FT. HEEL ~ 7°

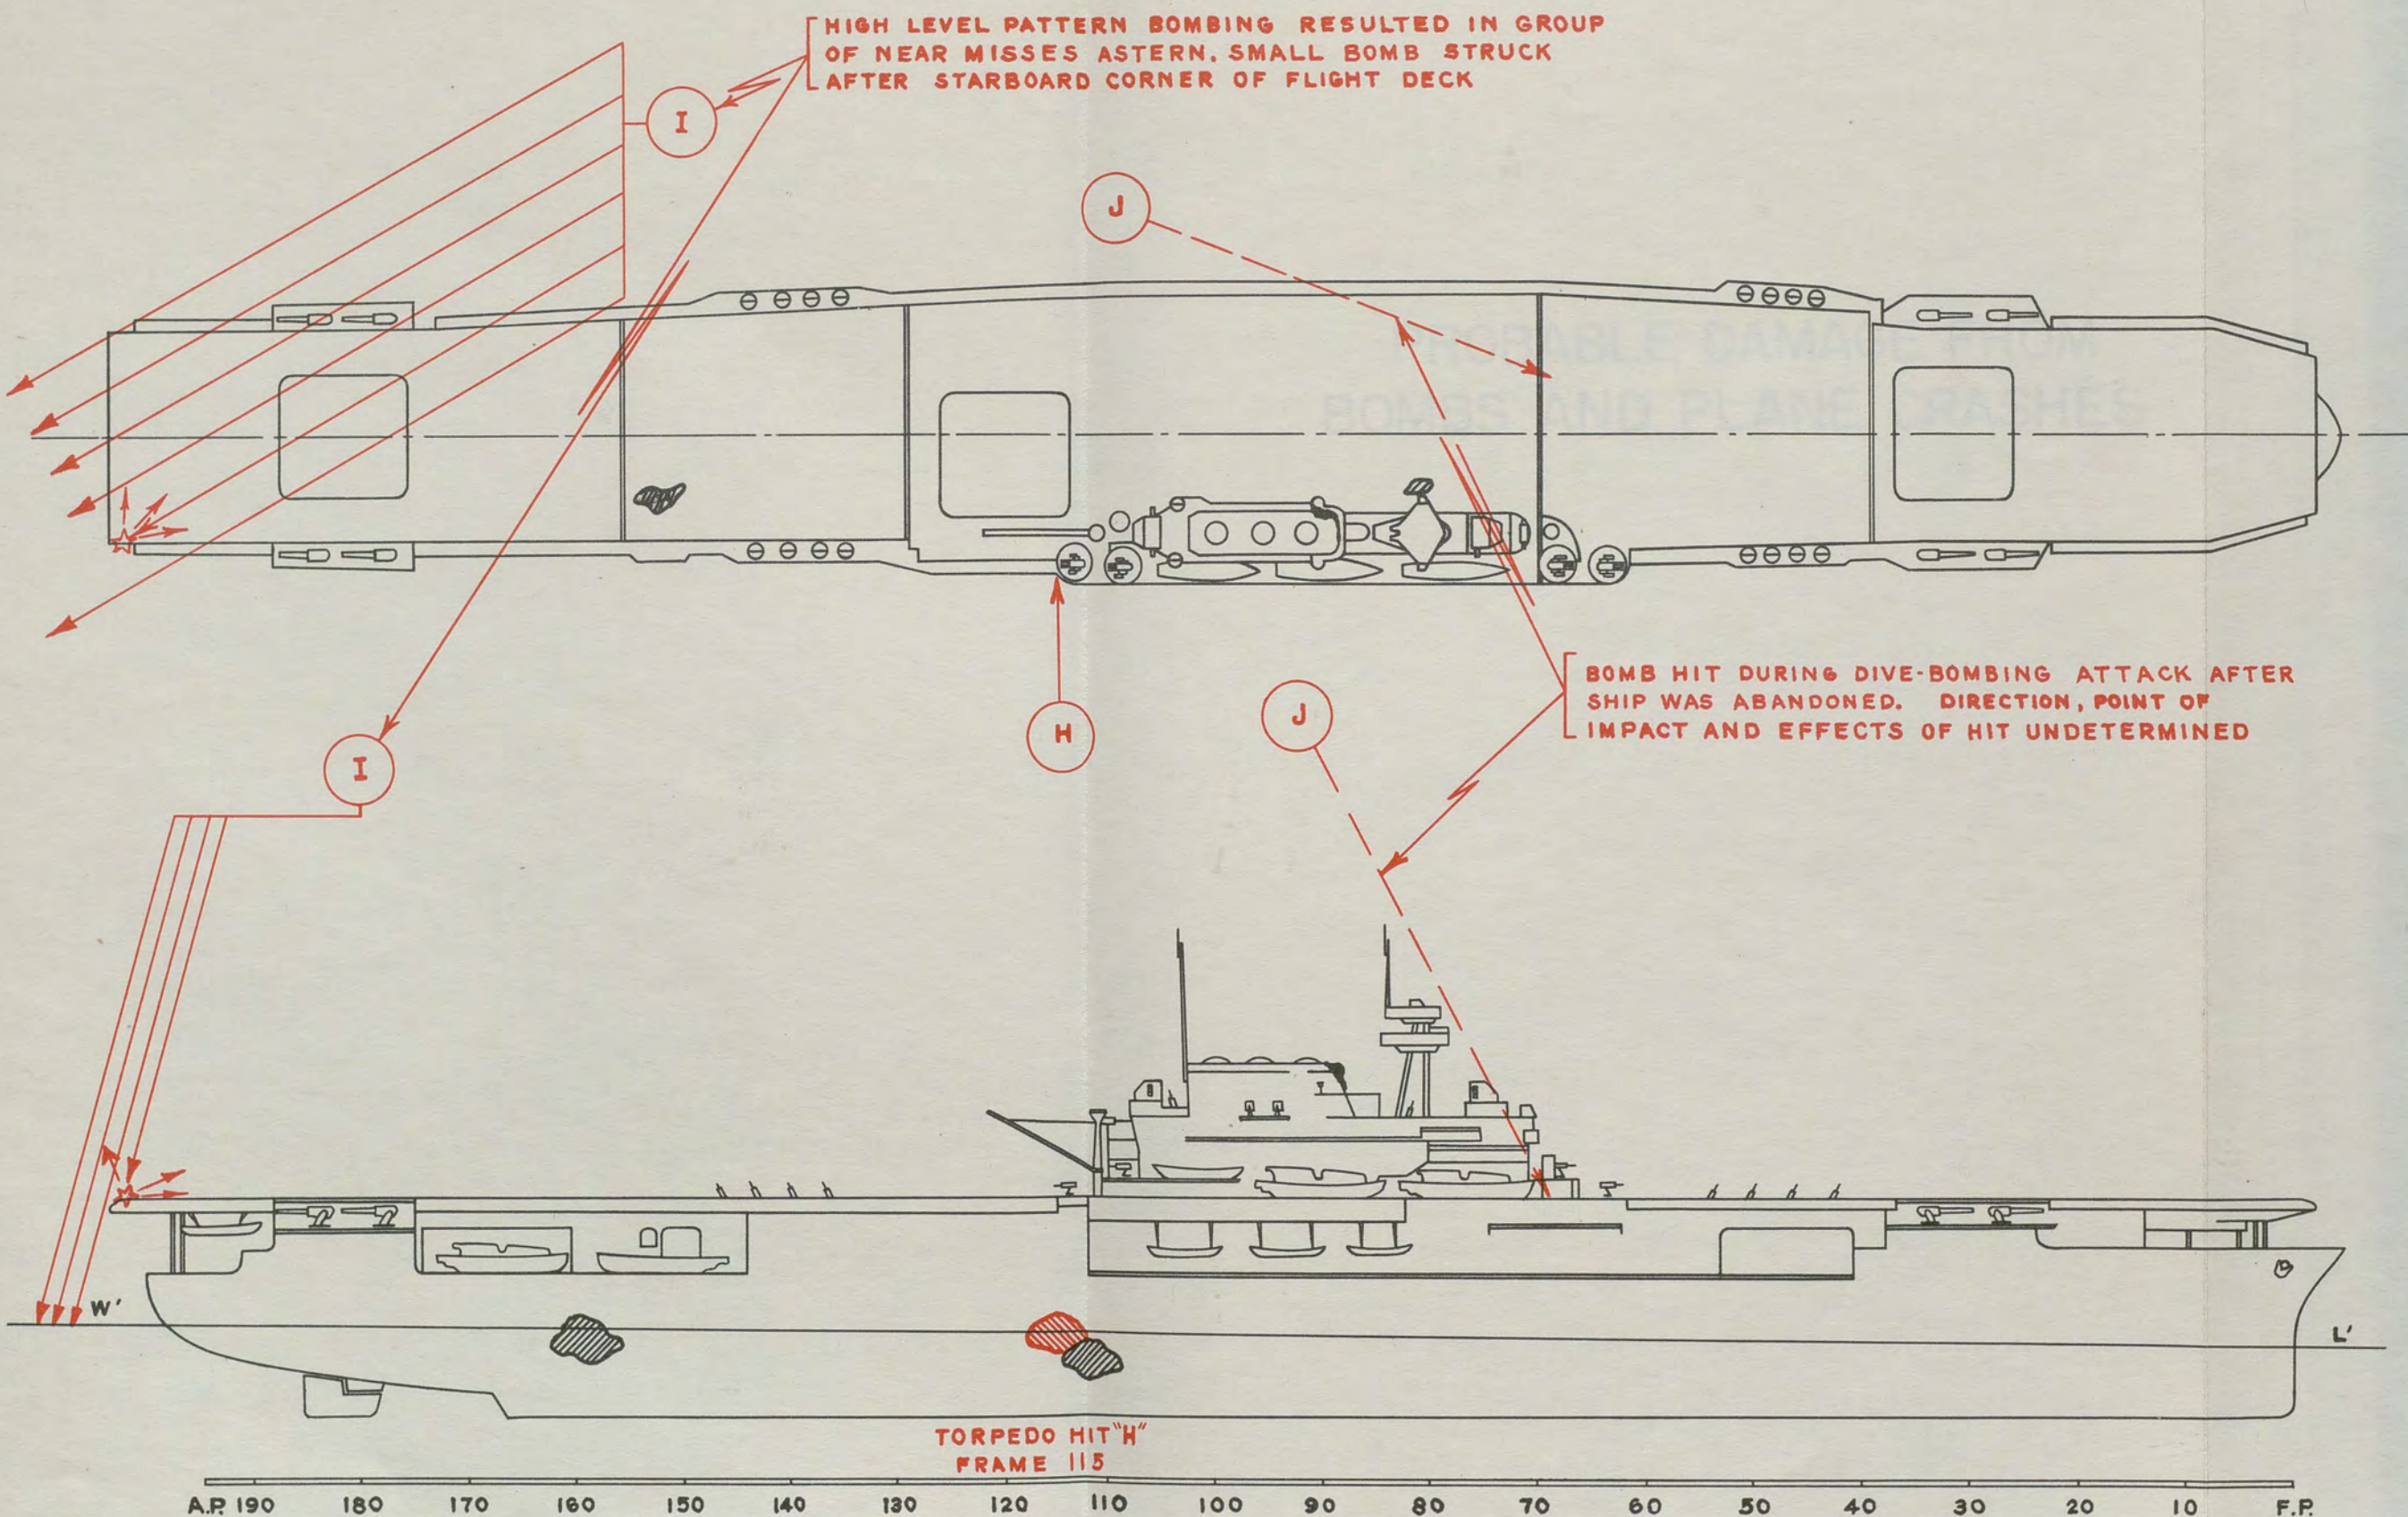
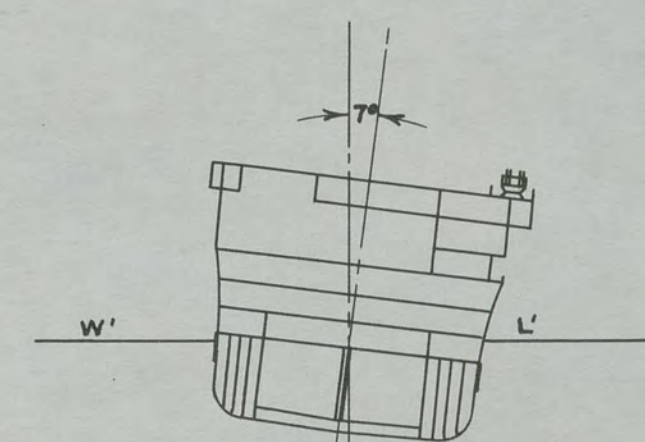
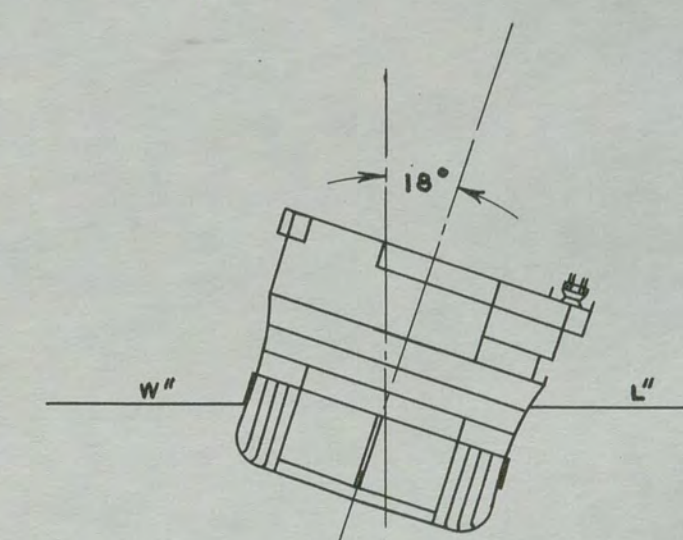
AFTERNOON ATTACKS

CONDITION BEFORE ATTACKS  
FRAME 112 ↪ LOOKING FORWARD  
MEAN DRAFT-30.5' ↪ HEEL-7°

CONDITION AFTER ATTACKS  
FRAME 112 ↪ LOOKING FOR'D  
DRAFT UNDETERMINED  
HEEL AT 1650 ↪ 18°
