U. S. S. RENO
(CL96)

TORPEDO DAMAGE

OFF LUZON
3 NOVEMBER, 1944

WAR DAMAGE REPORT No. 55

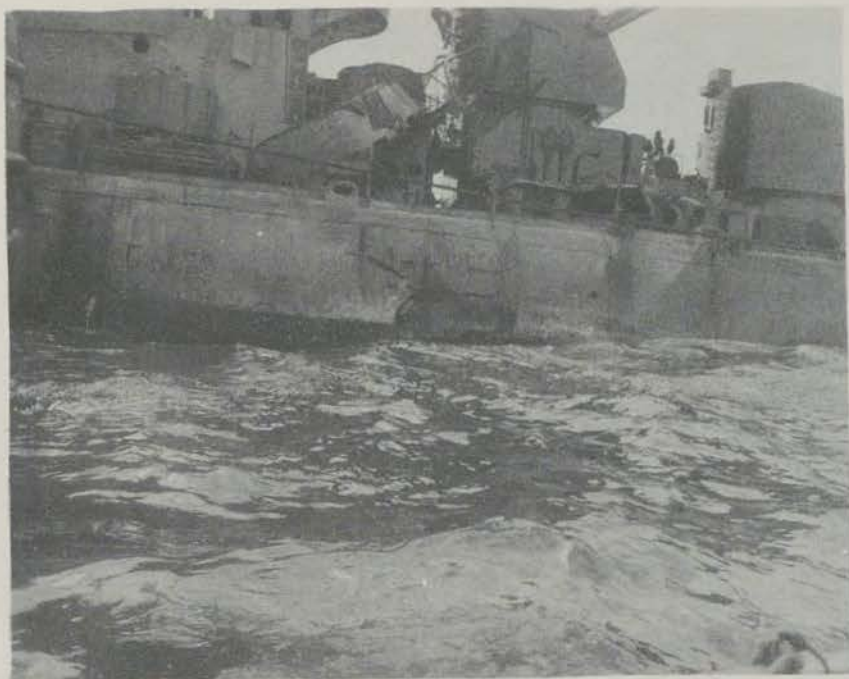
Photo 1: Port side in way of damage. Ship has starboard list.

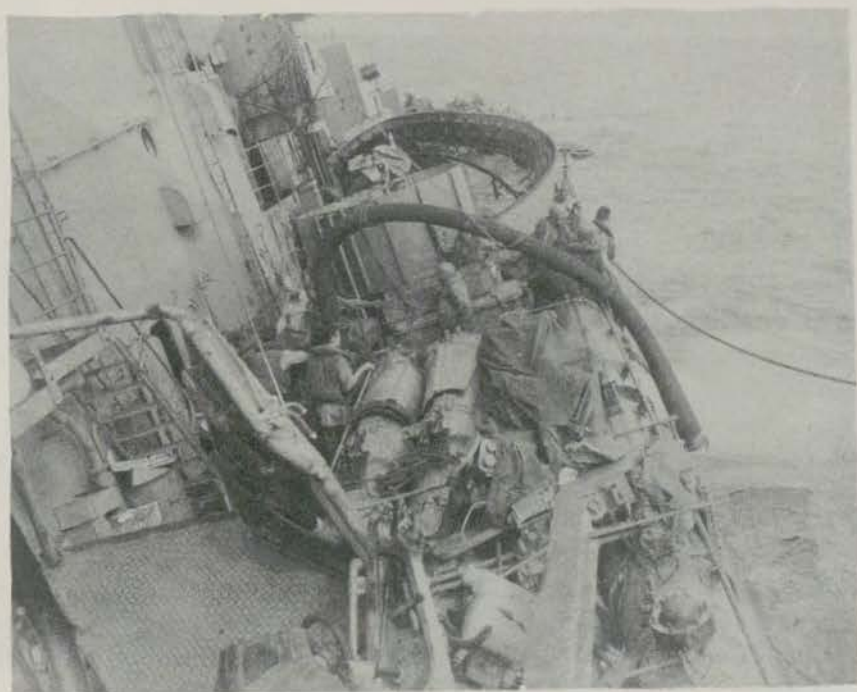
Photo 2: Looking aft on port side showing damaged 40mm and torpedo tube mounts. Discharge line from 6-inch pump in B-207-L visible. Ship has starboard list.

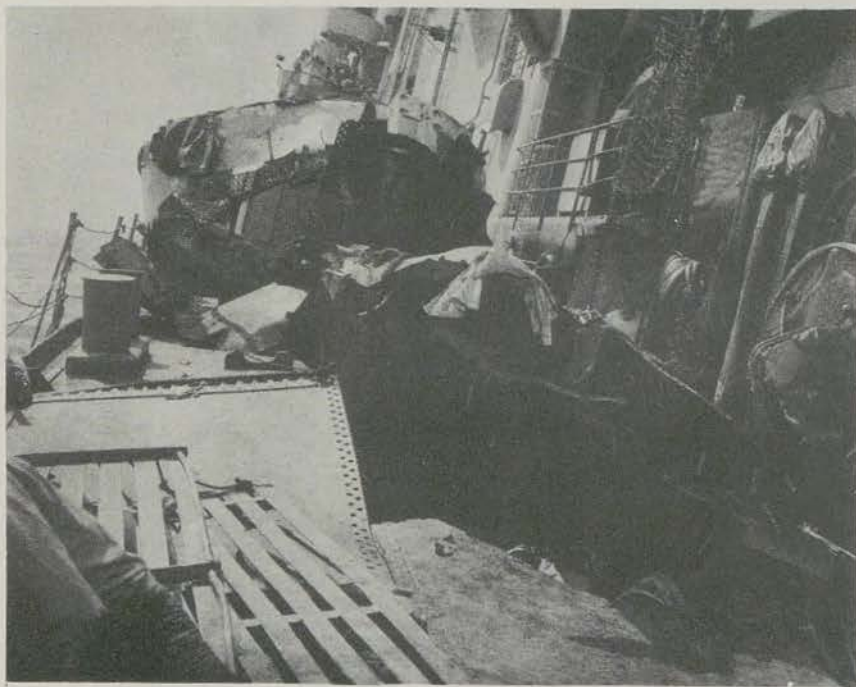
Photo 3: Looking forward on port side showing ruptured main deck.

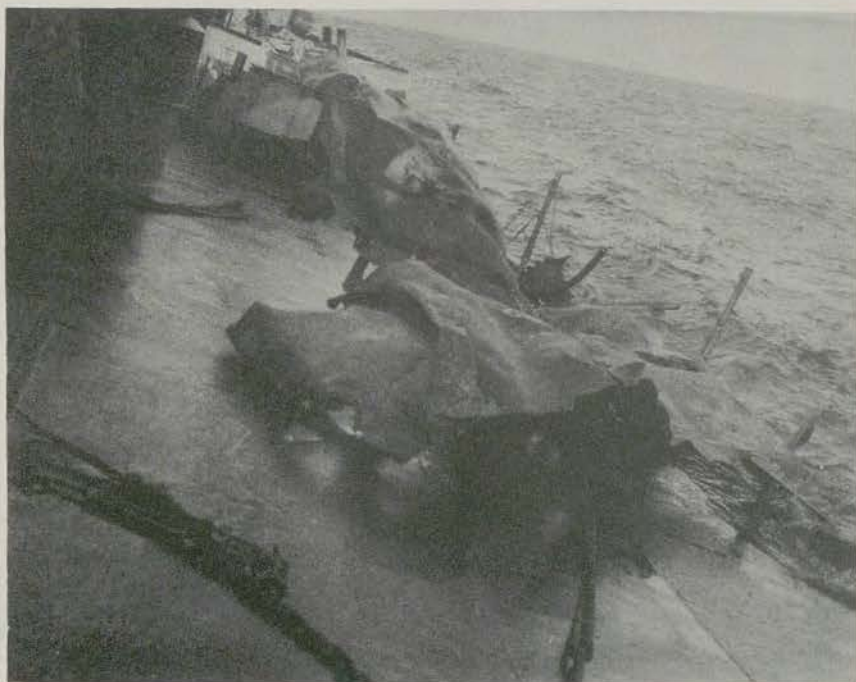
Photo 4: Parts of main and second decks on port fantail. Ship has port list.

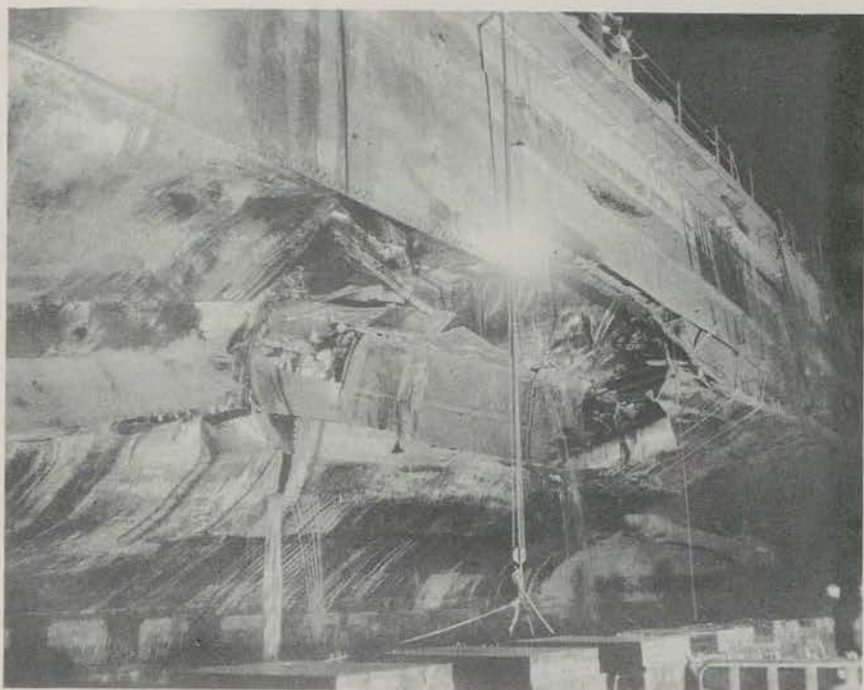
62. The port longitudinal STS bulkhead (tapered from 3.75 to 0.75 inches, similar to bulkhead 90), only 14 feet from the point of detonation, was pulled away at the riveted connection to bulkhead 90 and to the 1.25-inch STS first platform between frames 90 and 100 and was carried to starboard by the force of the blast (Photo 5). However, this longitudinal armored bulkhead remained practically intact and was effective in restricting the depth of damage, the main force of the explosion being

directed upward as evidenced by extensive damage to the main and second decks. This restriction of the depth of damage preserved sufficient structural strength for RENO to travel 700 miles through rough seas with no apparent progressive failure. The 1.25-inch STS deck over C-406-M, C-402-T, C-402-1/2M and C-405-E was raised about 3 feet and split at a welded butt (Photo 7).

Photo 5: General view of torpedo hole looking aft. Note side armor over hold is intact. Longitudinal armor outboard of magazines limited depth of damage. Note tear in armored first platform deck.

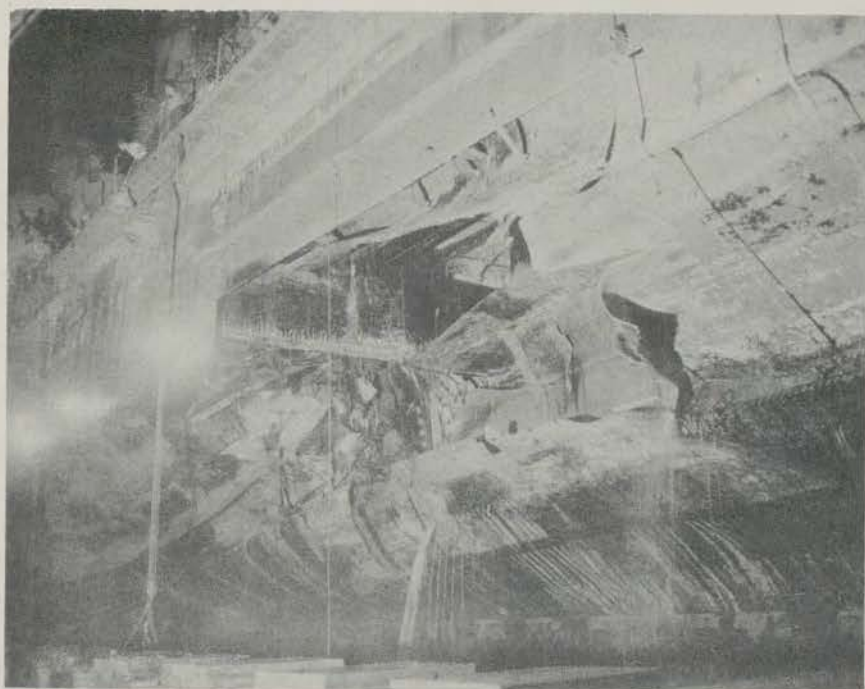
60. Structural damage was restricted to the area of the hit. There was no wrinkling of the deck or shell plating in way of the hit nor at the quarter-points as a result of flexural vibration of the hull. The shell plating was ruptured over an oblong area, approximately 33 feet long and 22 feet around the girth of the ship, between frames 88 and 96, and around the girth between 10 and 32 feet below the main deck level (Photo 5). Serious indentations of the shell plating occurred around the periphery of the hole from frame 80 to 105 and several feet above and below the hole. The seam joining "B" and "C" strakes port was torn from the after part of the hole as far aft as frame 105. The aftermost plate of the armor belt (3.75-inch STS), which extended eight feet over the opening in the shell plating, was only slightly distorted (Photo 6).

61. The 3.75-inch STS transverse bulkhead at frame 90 between the first platform and second deck remained intact. Bulkhead 88 between the main and second deck was thus shielded sufficiently so that it could later be shored and made tight. Below the first platform, bulkhead 90 has an STS strake 3 feet 9 inches high that tapers from 3.75 at the top to 1.8 inches at the bottom. Thence, 0.75-inch STS extends to the shell connection. The section of this bulkhead outboard of the port longitudinal STS bulkhead was demolished at the bottom; the riveted connection at the first platform level failed and the upper part of the bulkhead was blown against bulkhead 88.

Photo 6: General view of torpedo hole looking forward. Note armored transverse bulkhead 90 is intact above the first platform level.

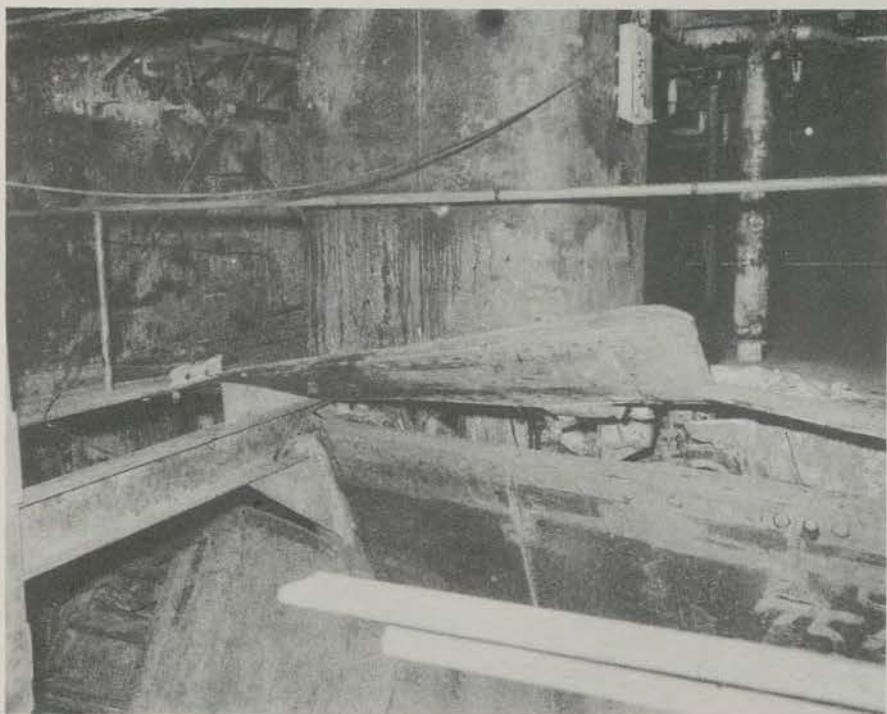
Photo 7: Looking inboard and forward into C-305-L. Note distortion of STS armor and tear in welded butt joint in armored first platform deck.

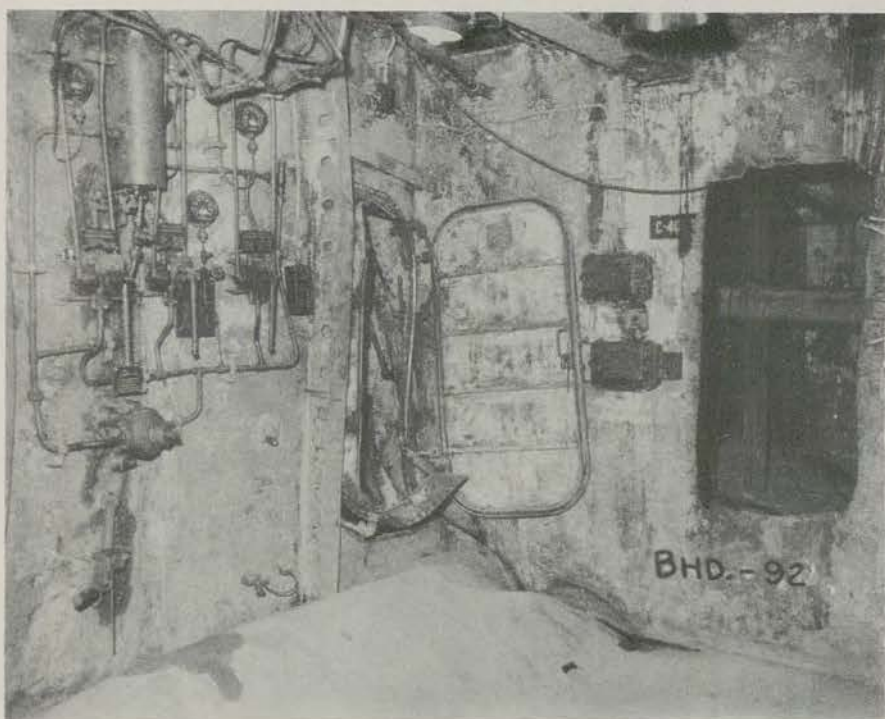
Photo 8: Looking forward and to port in after gyro room (C-405-E). Note distortion of deck and door 4-92.

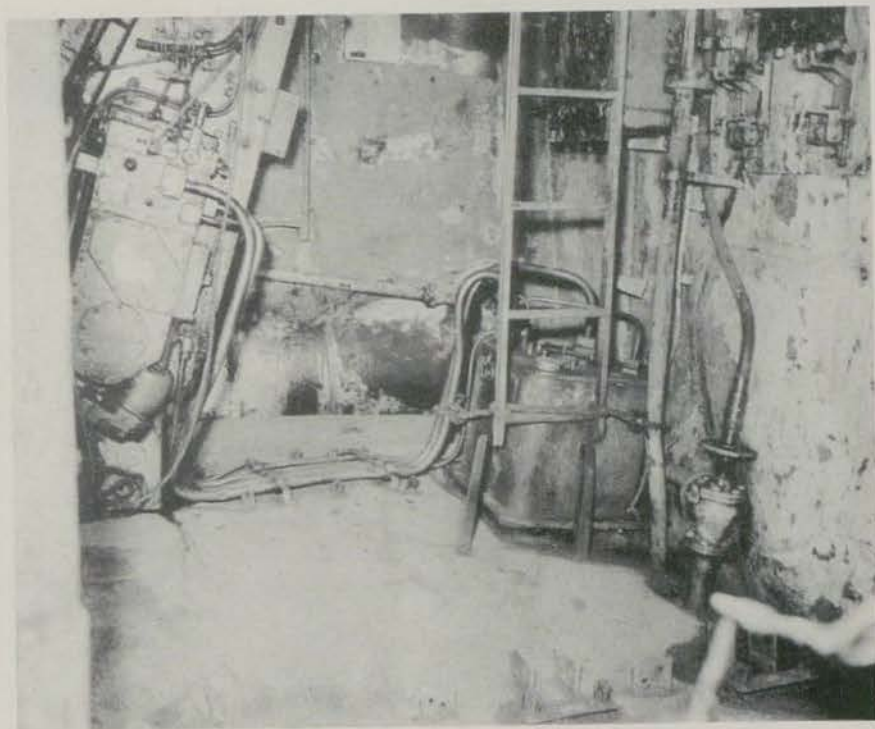
Photo 9: Looking forward and to port in C-407-1M showing distorted bulkhead and decks in way of the 5-inch ammunition hoist.

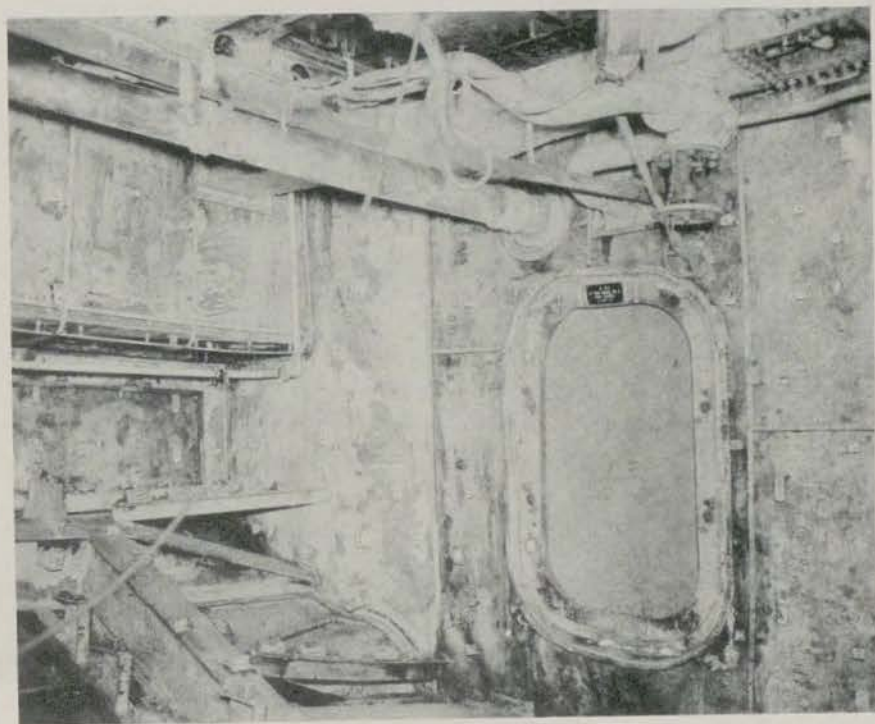
Photo 10: Port side of the forward bulkhead of C-411-M showing buckled bulkhead and blanked-off doorway.

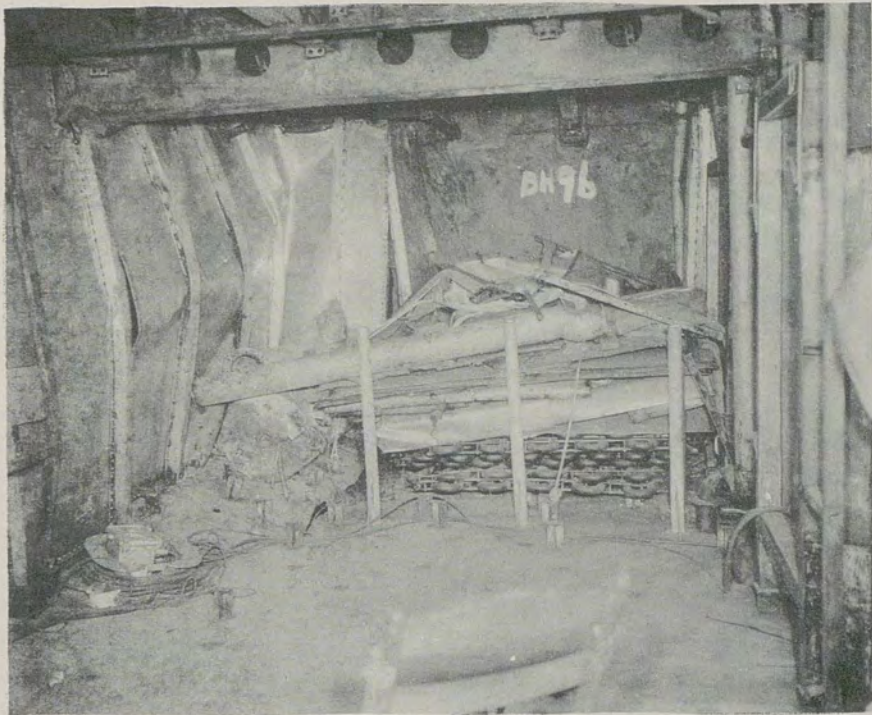
to flood. The remainder of the compartments between bulkheads 96 and 103 were separated only by light airtight bulkheads which failed under water pressure and caused the meat room (C-307-6A), fruit and vegetable room (C-307-5A), vestibule (C-307-2A), passage (C-307-1T) and laundry room (C-307-3E) to flood completely. Hatch 2-104 was open at the time of the hit but was closed when Material Condition ABLE was set. It was later found to be improperly dogged, permitting the main issue room (C-311-AL) to flood progressively from C-203-2L to within two feet of the overhead.

Photo 11: Looking forward in C-307-6A showing damaged bulkheads and torn deck plating.

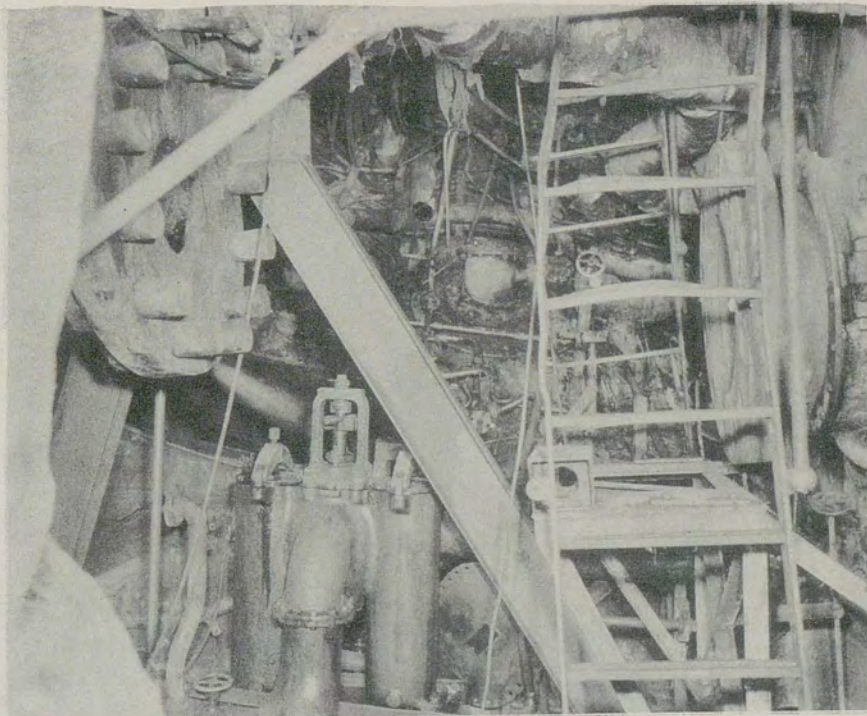
64. The damage sustained by the machinery in the after engine room was primarily caused by the 67-day period of submergence in salt water. The port shaft coupling bolts were pulled through the flange at the main reduction gear by the force of the explosion allowing the shaft to slip aft 54 inches (Photo 12). The shaft did not tear a hole in the engine room bulkhead as in the case of HOUSTON (CL81)* and CANBERRA (CA70).**

Photo 12: Looking to port in the after engine room (B-4) showing port shaft separated 4-1/2 feet from reduction gear.

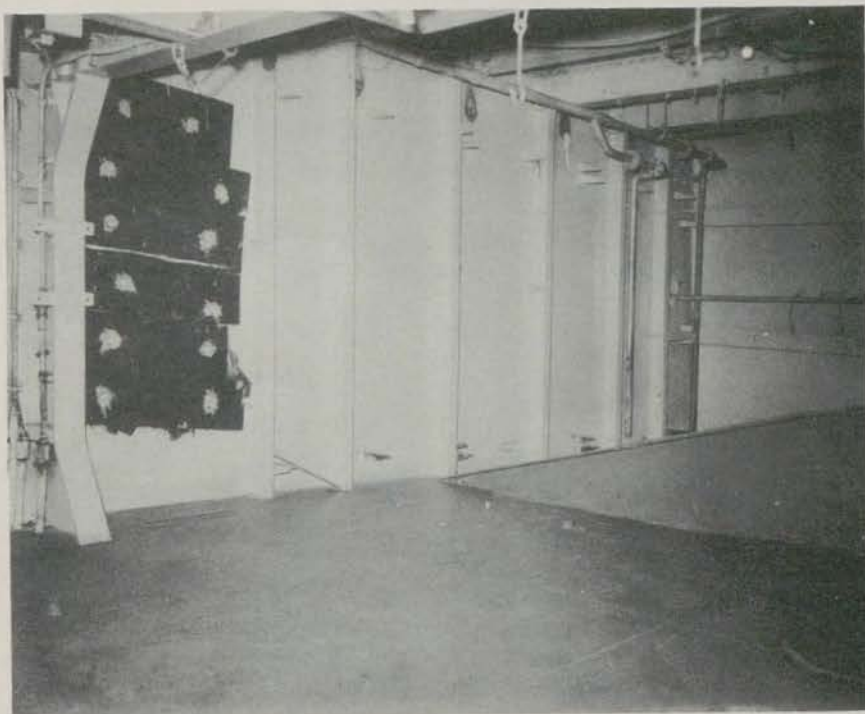
88. If the second deck doors had been closed, the flooding forward would have stopped at bulkhead 77. The frame of door 2-103-2 was warped so that it could not be closed. However, had this door been closed when the torpedo hit, it might have deformed with the frame and bulkhead and permitted only minor leakage. If the flooding aft could have been stopped at bulkhead 103, eliminating the large free surfaces in C-203-L and C-311-AL, RENO would have maintained positive initial stability. Also, there is a possibility that if the doors 2-88-1 and 2-88-2 had been closed, they might have remained closed and slowed the flooding of B-207-L to such an extent that it could have been controlled. There are many instances in war damage experience of closed doors deforming with the bulkheads and yet remaining reasonably tight. However, once a deformed door is opened, it usually has proved impossible to make it reasonably watertight again except where circumstances have permitted shoring.

Photo 13: Looking aft and to port at bulkhead 103 from C-202-L showing patch installed in door 2-103-2 by ship's force. T-beams at right were installed at Ulithi.

25. Efforts to reduce the extent of flooding were commenced soon after damage was received. It was found that door 2-103-2 could not be closed because the door frame was warped. The door was removed and the opening blanked off by heavy timbers. The forward bulkhead of C-203-L was shored during the next three days as a precautionary measure. At 0800 on 4 November attempts were made to lower the water in compartment C-203-L with handy-billies, but the large amount of leakage into the compartment and the limited capacity of the pumps prevented any appreciable progress. At 0830 these pumps were shifted to the after fireroom, where an inspection had indicated that efforts to pump the compartment dry would be more successful.

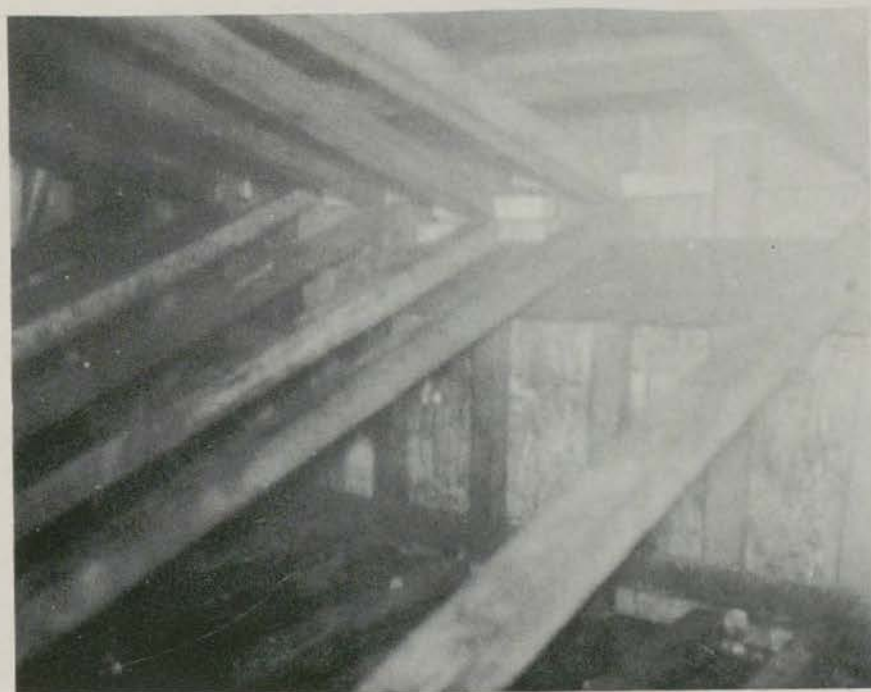
Photo 14: Shoring installed by ship's force against port side of bulkhead 103 in C-203-L.

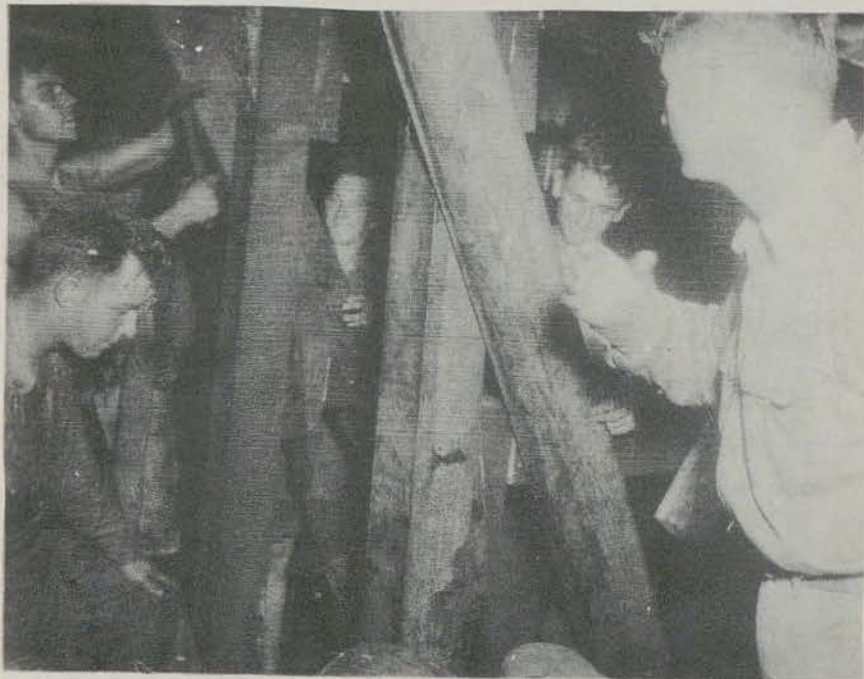
Photo 15: Shoring installed by ship's force against port side of bulkhead 88 in B-207-L.

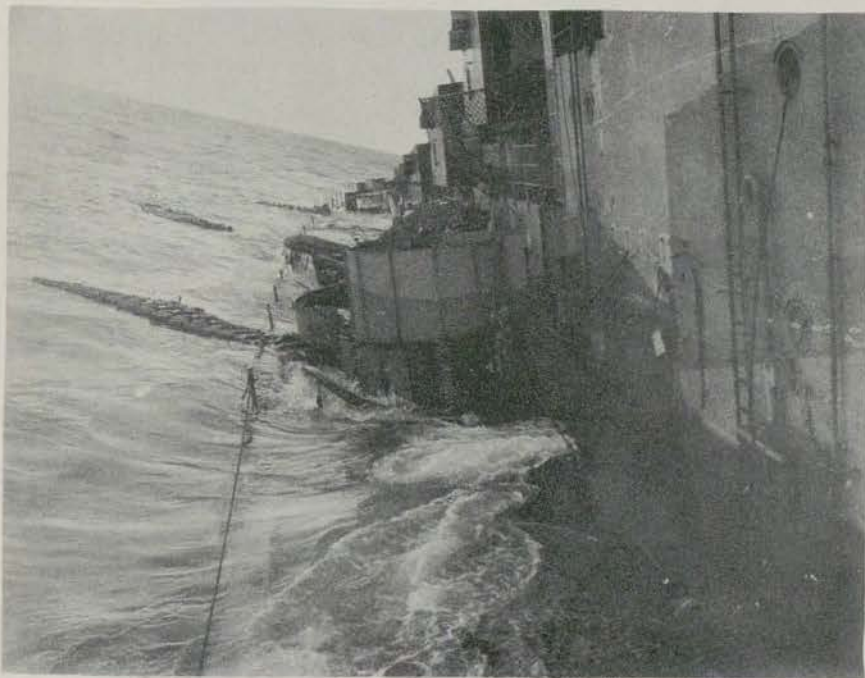
Photo 16: Looking aft on starboard side showing main deck awash.

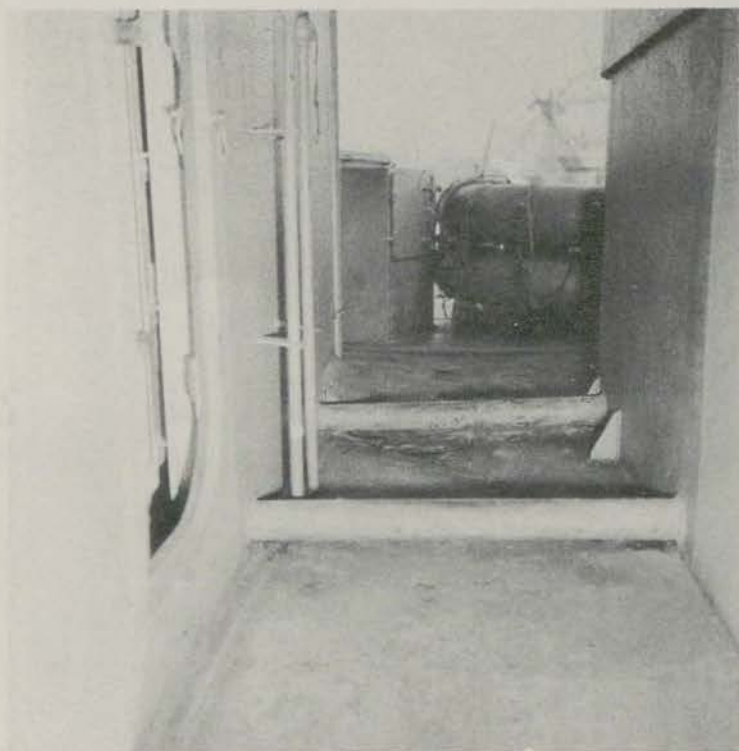
Photo 17: Looking to starboard through main deck passage-way at frame 91-1/2 showing wrinkles in deck plating. Four-inch pipe stiffeners were welded between deckhouses by ship's force.

50. By the morning of the ninth, the seas had abated sufficiently to permit emergency structural repairs topside. A 3-foot by 5-foot section of 10-pound plate was welded over the ruptured butt in the main deck stringer at frame 94-1/2. Three 4-inch pipe stiffeners were welded between the deckhouses at frames 91 and 92 (Photo 17) to prevent cracks in the main deck from progressing.

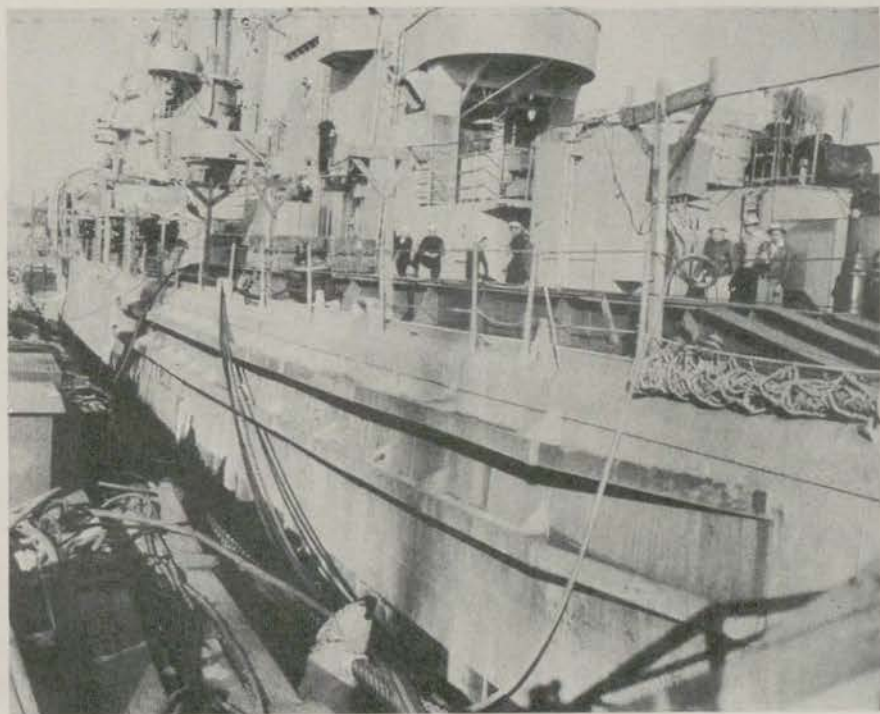
Photo 18: View of port quarter showing 24-inch T-beams installed at Ulithi.

55. Temporary above-water repairs were effected at Ulithi under the direction of Commander Service Squadron Ten. VESTAL (AR4), assisted by the ship's force, repaired the holes in the main and second decks. Three 24-inch welded T-beam stiffeners were installed on the port side of the main and second decks, extending continuously between frames 77 and 103, a distance of 104 feet (Photo 18). The port sheer strake was largely intact, but it was reinforced by two longitudinals on the outside of the shell plating in way of the existing longitudinals (Photo 18). Five-inch gun mounts Nos. 4 and 5 were removed and retained at Ulithi. Compartments C-412-2M and C-415-M were pumped out. However, dewatering of all compartments had to be delayed until arrival at Manus, where adequate drydocking facilities were available.

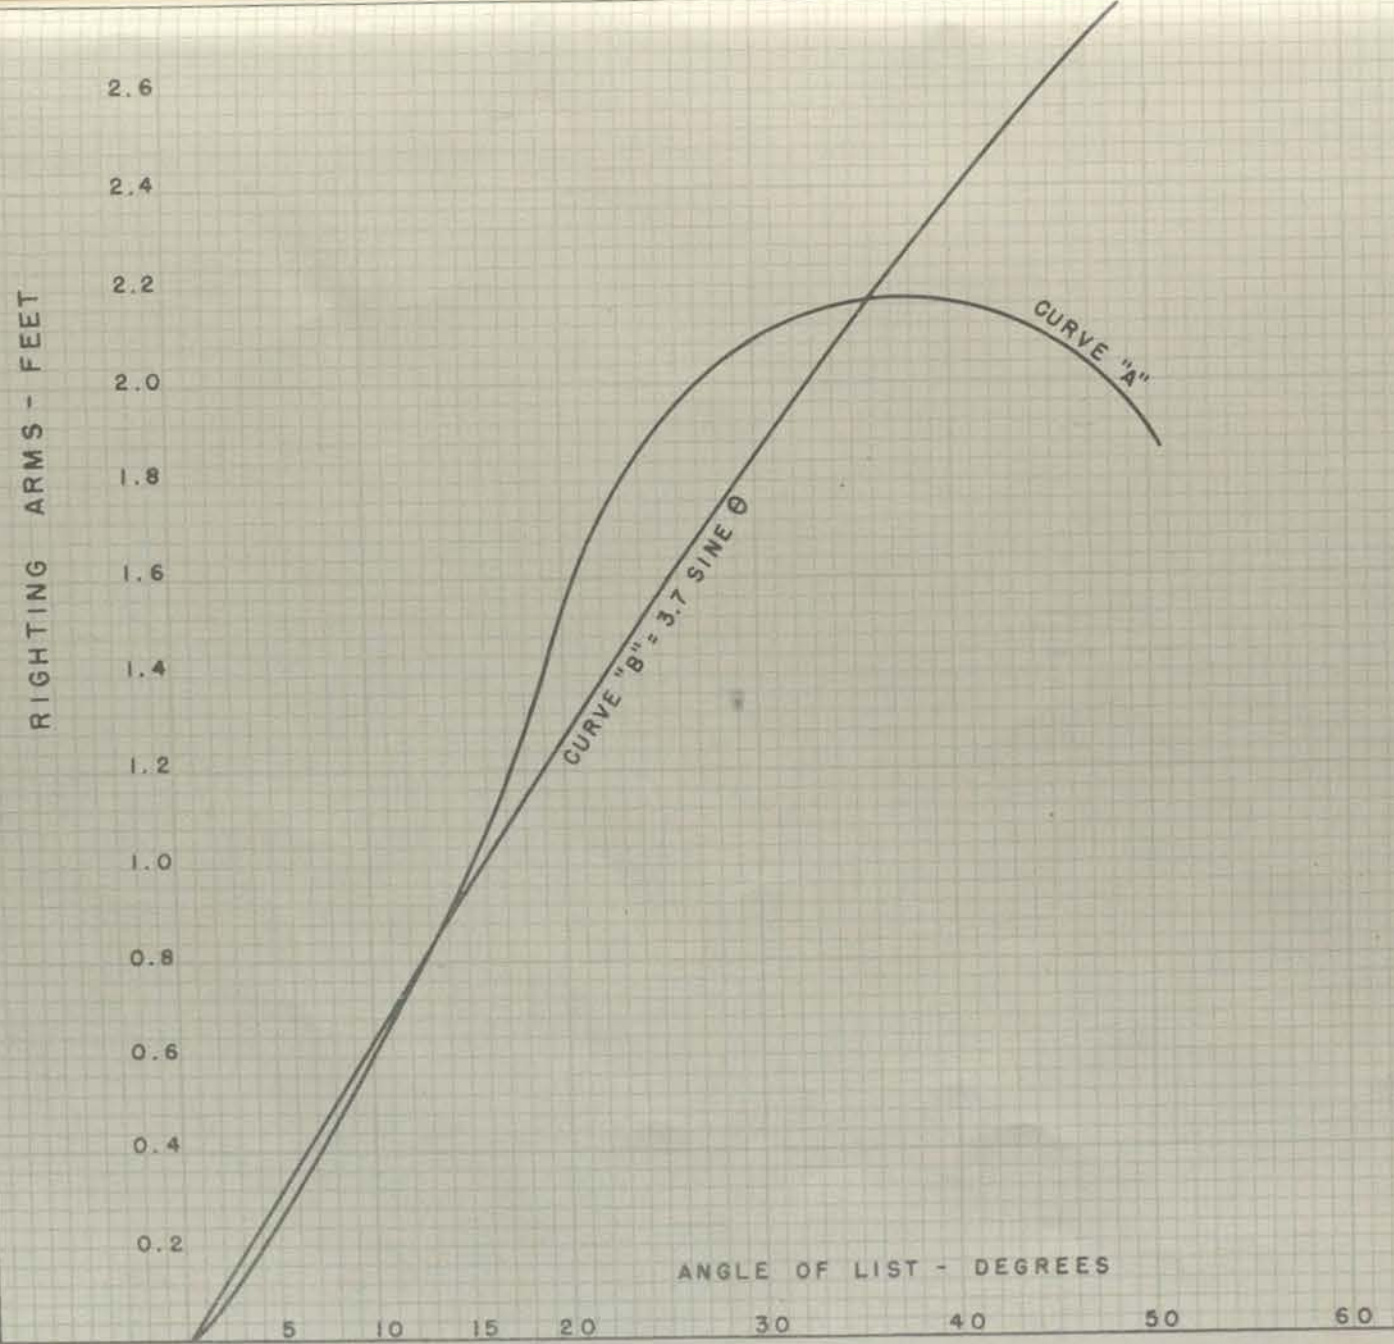
PLATE II

78. In developing Plate III the statical stability curve for the ship in an undamaged condition and a displacement of 11,250 tons was derived from the cross curves of stability (Curve A, Plate II). An assumed KG of 20 feet was used in developing the cross curves of stability. Curve B, Plate II, was plotted equal to $3.7 \sin \theta$. The difference between Curve A and Curve B gives a statical stability curve corrected to a KG of 23.7 feet, which when multiplied by the displacement of the ship gives the statical stability curve of Plate III. The value of KG equal to 23.7 was selected because it was found by trial and error to give a righting moment at about 16 degrees starboard list equal to the maximum negative port righting moment due to instability. The statical stability curve of Plate III was plotted in terms of righting moment in foot-tons versus list to give the picture more clearly in moments. Plate III is a statical stability curve representing the condition of the ship at the time of the lurch. The shape of the curve to the right of the axis through the origin is that of a ship having negative initial stability and that to the left is the same curve with opposite sign.

U.S.S. RENO CL-96
UNCORRECTED
STATICAL STABILITY CURVE
FOR DISPLACEMENT AT TIME OF LURCH
AND
SINE CURVE WITH AMPLITUDE OF 3.7

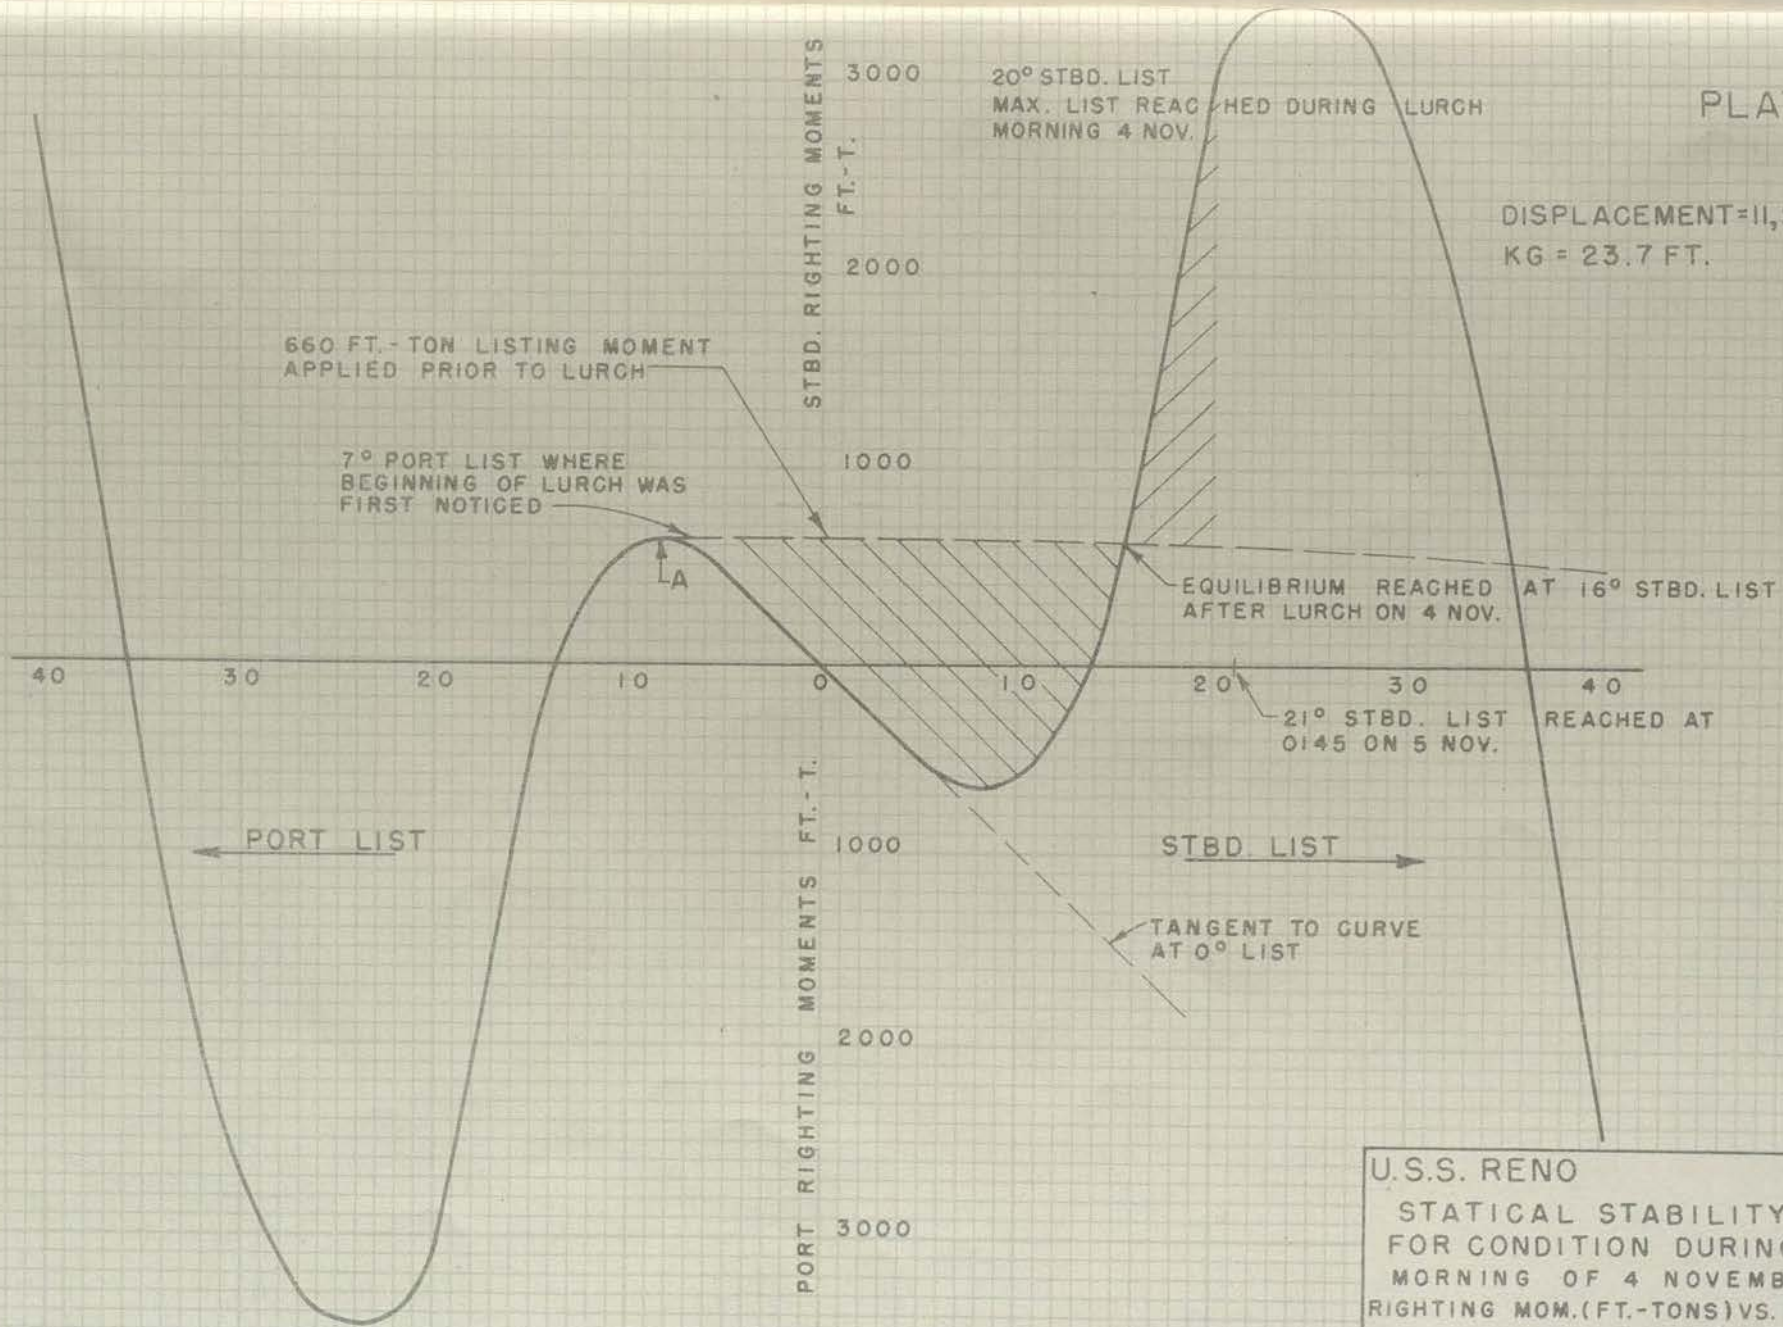
80. Although the method of analysis illustrated by Plate III is admittedly not exact at large angles of list as stated in paragraph 77, it will be noted from the curve that the range of stability was reduced considerably, to about 36 degrees. The above discussion indicates that a condition of negative GM and greatly reduced range of stability undoubtedly existed in the early morning hours of 4 November. This, of course, means that reserve of dynamical stability at that time was very meager. The ship was in grave danger of capsizing.

U.S.S. RENO CL-96
 STATICAL STABILITY CURVE
 FOR CONDITION DURING LURCH
 MORNING OF 4 NOVEMBER, 1944
 RIGHTING MOM.(FT.-TONS)VS. LIST (DEG.)
